# Inspection Report

1060 Trail

Atlanta Georgia 30328

**Inspectors Associates, Inc.**

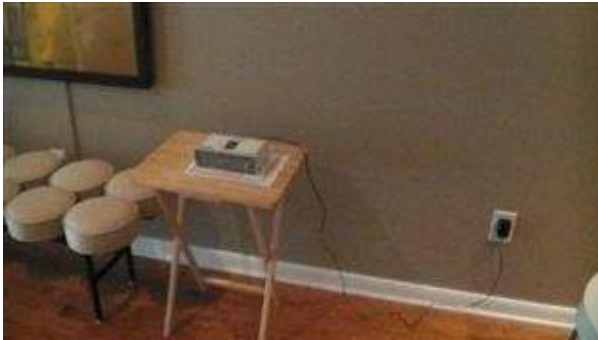
2.8 Picture 1

The test results came back as elevated and the report has been submitted. Mitigation is recommended.

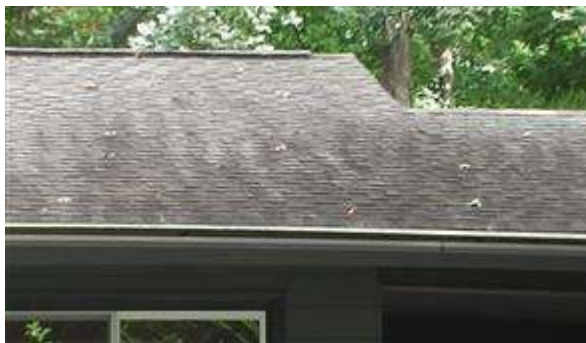
3. COVER  
2 Comments: "R" Place in line for repair  
Roof is in need of cleaning and service. Repair damaged shingles, replace defective boots.

3.2 Picture 1. full cleaning and service required

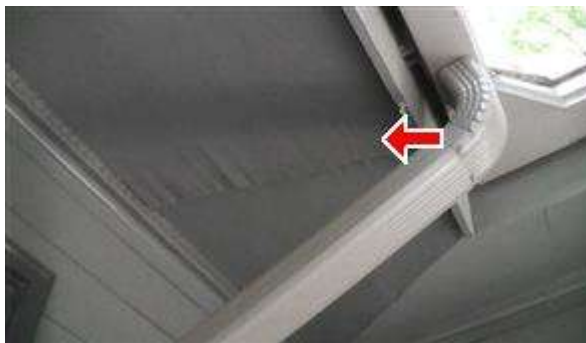
3.3 Picture 1

3. EAVE &  
3 Comments: "R" Place in line for repair  
(1) On the rear left corner where the Valley is there soffit delamination that will need to be repaired. This is just as you walk out from the family room door.

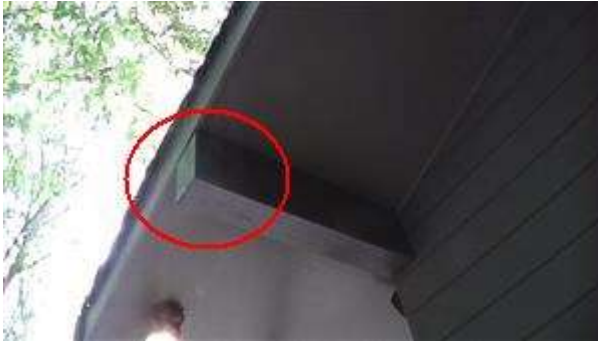
3.3 Picture 3

(2) Repair the wood damage to the beams that extend on the rear right coming off the master bedroom.

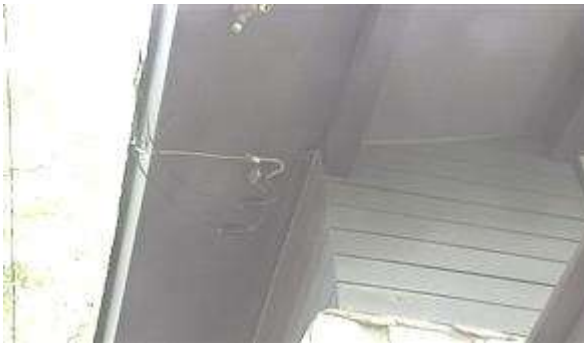
3.3 Picture 4

(3) The fascia board at the front left corner has wood rot damage. Repair.

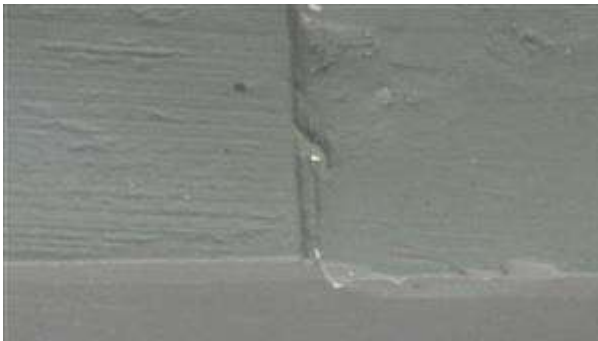
3.3 Picture 6

(4) Facia board at the right side just behind the gutter system is damaged and the board should be replaced.

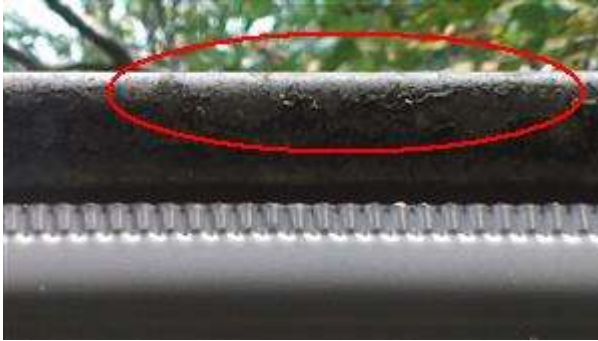
3.4 Picture 1

- (1) There is no gutter on the left-hand side of this property. I recommend adding a gutter.

(2) The gutter has gutter guards and they need to be cleaned.

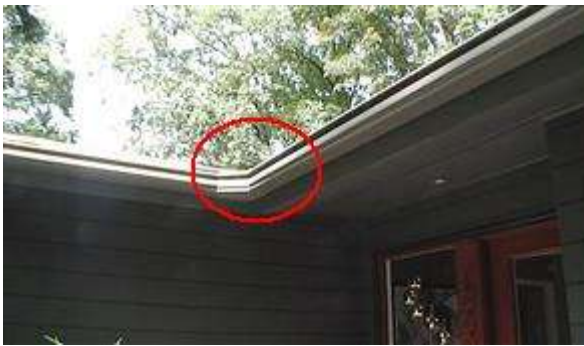
3.5 Picture 1

Valley guard should be installed at the front Valley to the entrance of the house. Front entrance is a protected area. Water spills over top of the Valley termination onto the front stoop during heavy rains.

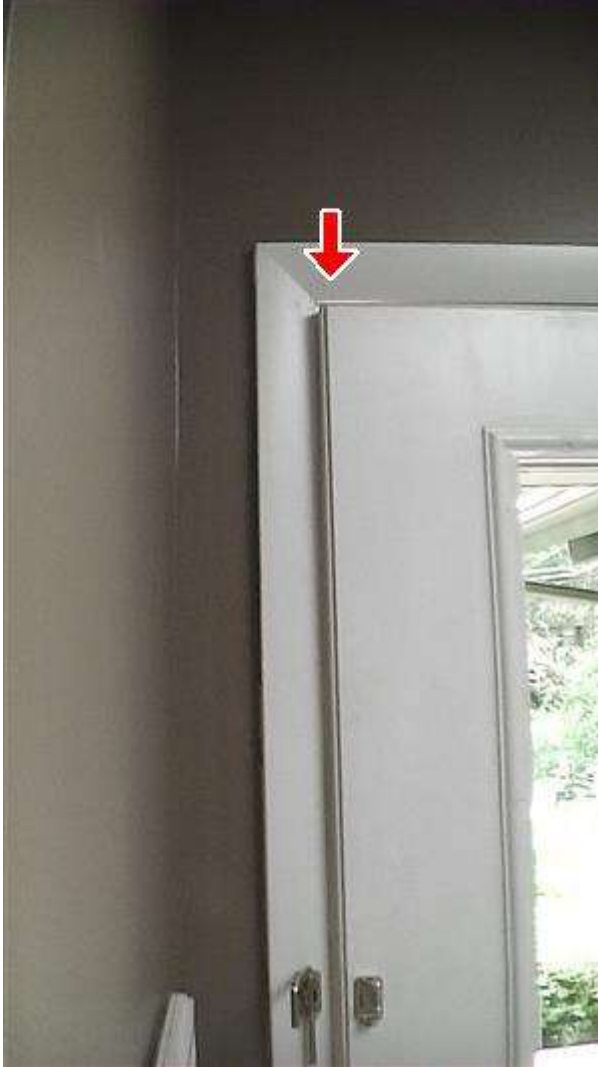
4.2 Picture 1

(1) The front door needs to be adjusted. It is binding at the top corner latching side.

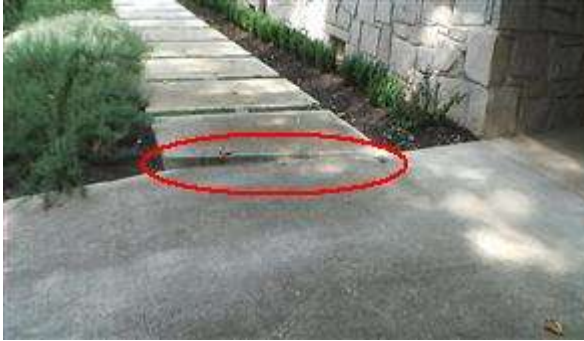
4.4 Picture 1

The way the stone walkway is tied into the driveway at the front represents a trip hazard. This should be leveled.

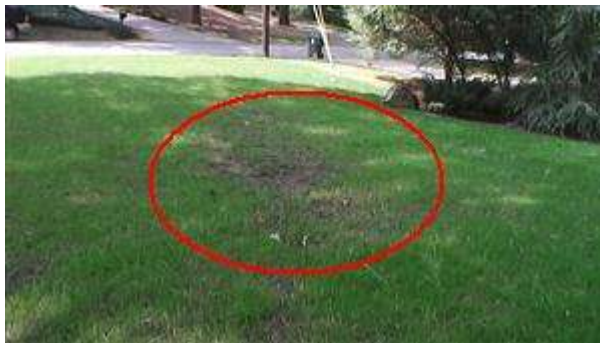
4.5 Picture 1

(2) There is a bare spot in the front yard towards the middle. It looks like this is where there is some moisture build up and possible erosion. Have the sellers identify

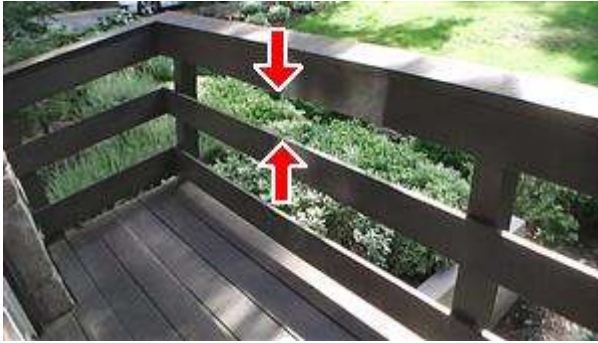
6.1 Picture 1

The balcony railing system off the front bedroom left side is greater than 4 inches on center and needs to be redone to reduce all openings to no greater than 4 inches.

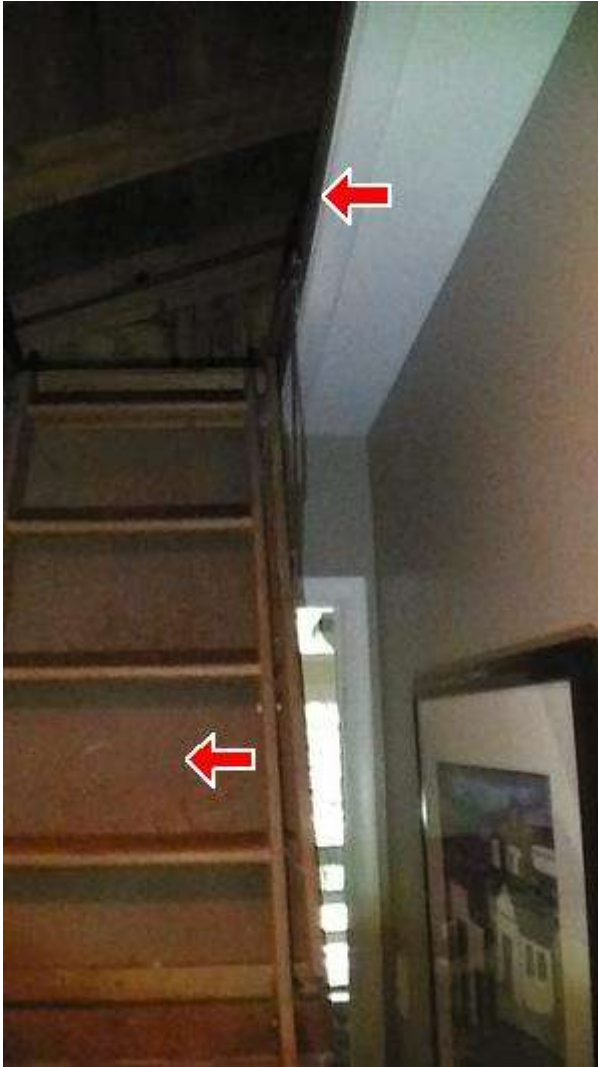
7.1 Picture 1

(1) Add insulation and weather stripping to the pull down attic stairs located in the bedroom, wing.

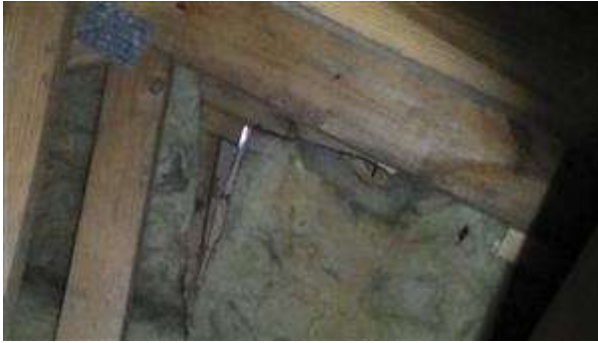
7.2 Picture 1

Insulation is approximately an R5. Bring this up to a minimum of an R30. Insulation along the knee wall is pretty low and it will need to be increased.

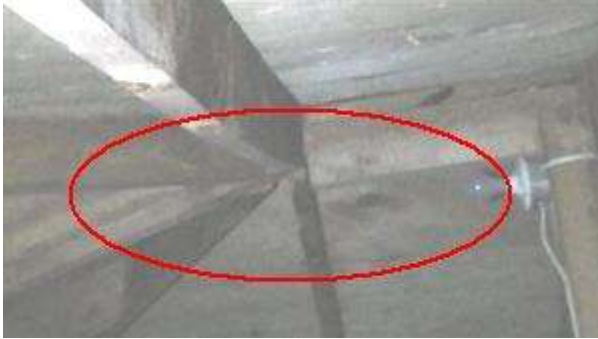
7.5 Picture 1

The ridge to hip connection on this roofline needs bracing and support. This is directly behind the pull down attic space entrance.

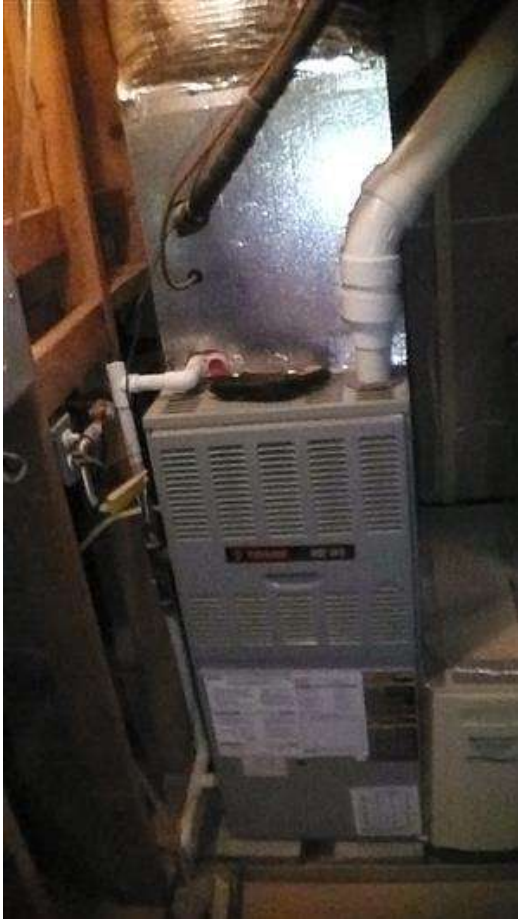
8.2 Picture 1

There is a secondary furnace system which manufactured by Train it has a safety shutoff valve and a condensate pump. The condensate pump needs to be put into a drain pan. This is a high-efficiency unit with a plastic vent pipe. Manufactured in 1997

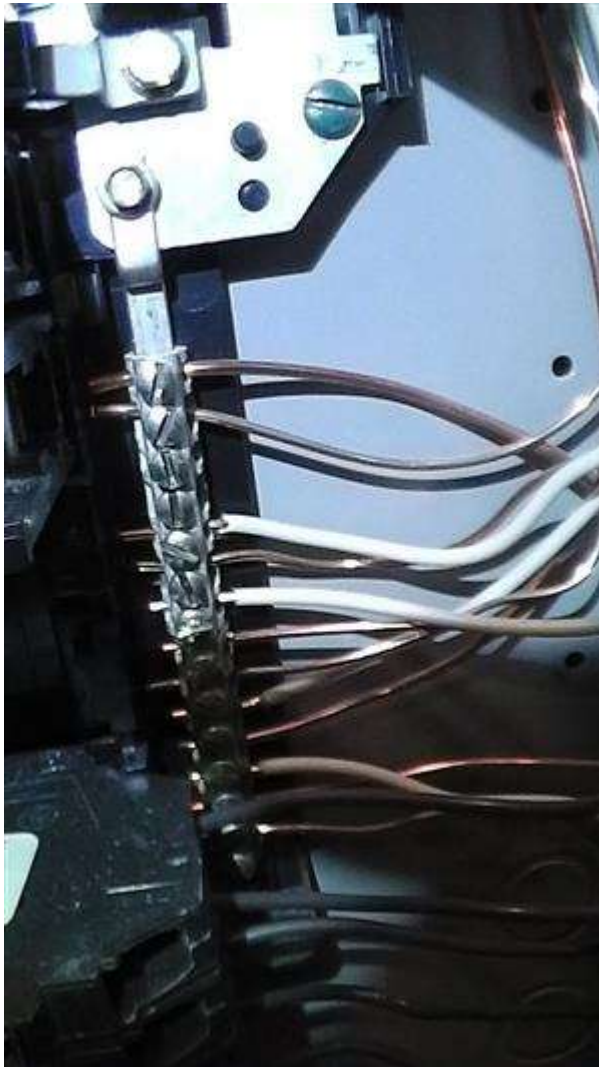
10.3 Picture 1

(2) The electrical panel box is not grounded. Repair. The neutrals and the grounds are combined.

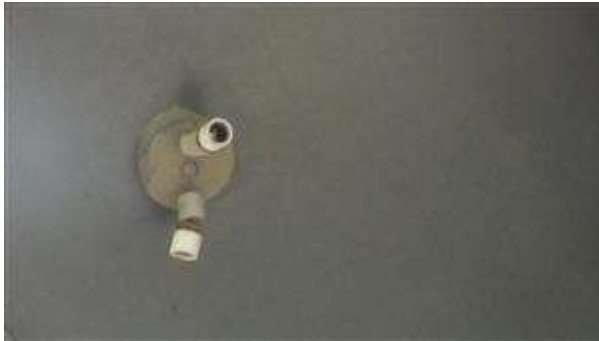
10.5 Picture 1

The exterior floodlights are missing on the front left corner. Add.

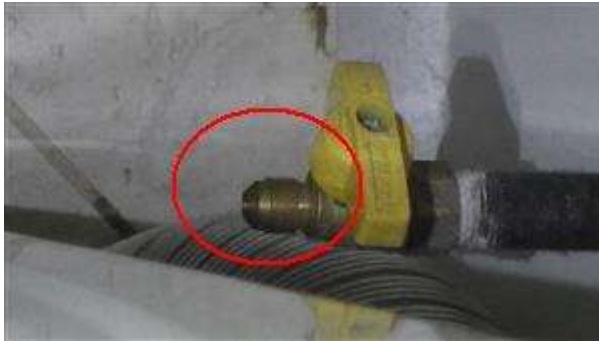
11.3 Picture 1

Cap the gas line in the laundry room. .

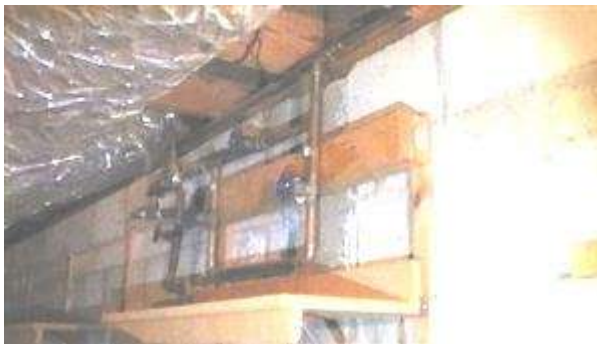
11.6 Picture 1

(1) The main incoming water line is copper coming through the wall. It is at the front of the house in the crawl space and the pressure regulator valve is located here as well. Need to add bonding around the pressure regulator valve.

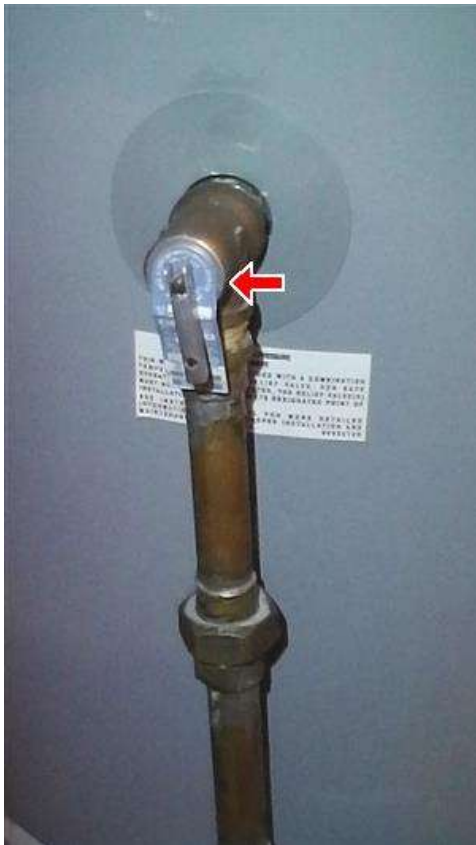
11.7 Picture 1

1. The T&P valve appears to be frozen into position. Have this serviced immediately.
2. Your water heater has a temperature and pressure valve. We do not operate these valves during our inspection due to the high risk of failure and leaks of the valve when tested. Statistically most people never test these valves and few even know it exists. As a result when tested after a few years they are prone to leak. You should make a point of checking your T&P valve every 6 months for operation and leaks. It is also a good practice to have this valve cleaned and serviced every 3 years. Call a plumber if you experience leaking or a seized condition. (V), (M), (FYI)

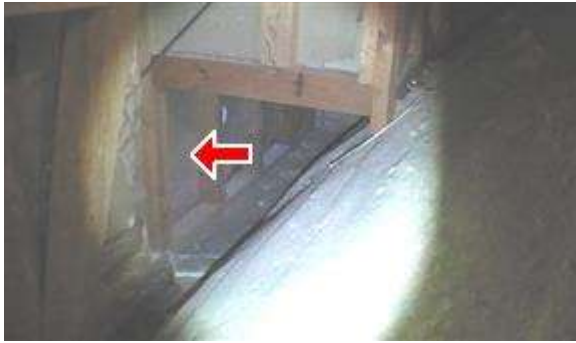
13.2 Picture 3 missing insulation

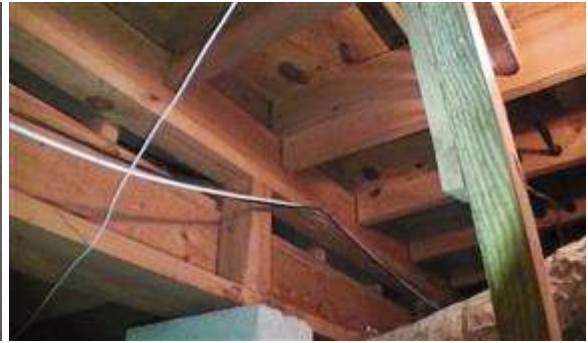
13.2 Picture 4 Need insulation under the floor

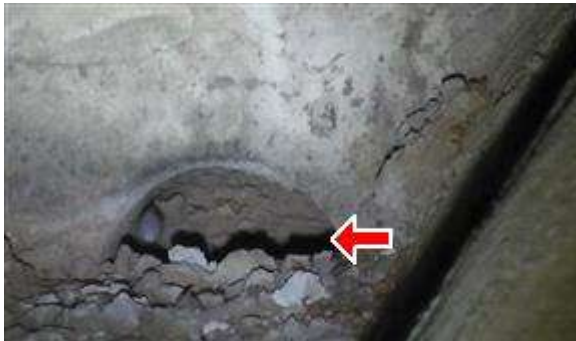
13.3 Picture 1

(1) Underneath this rear left corner in the crawl space at the bottom of the foundation wall there is a drain opening. I do not know where it terminates. It should be tested and evaluated. Currently there are some loose stones blocking the drain. Clear and evaluate. All drains of this kind should have a back flow preventer to avoid water intrusion into the interior.

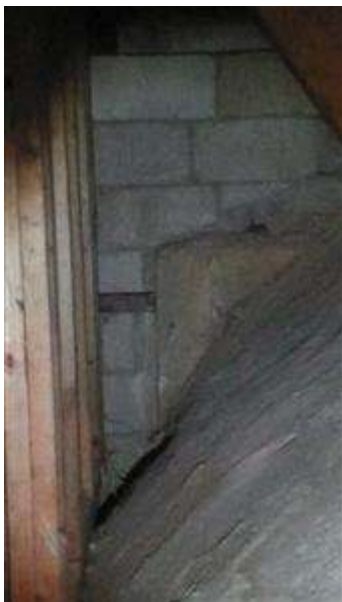
13.3 Picture 3 rear  
left corner in the  
crawl

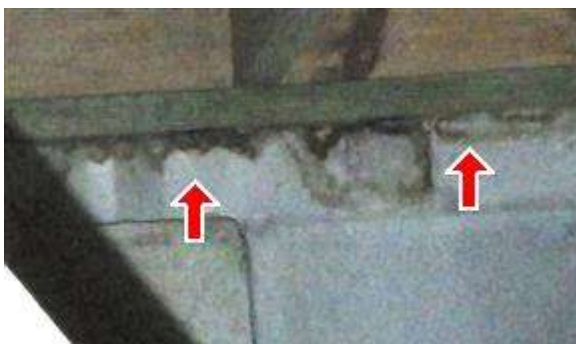
13.3 Picture 4

(2) Along the rear block wall at the sole plate there are water stains. This intrusion comes from the exterior due to the patio being higher than the top of the foundation wall. The patio should be lowered or provisions made to install a drainage system to capture the water below the top of the foundation wall on the outside patio

Where there's a lot of water in the inside crawl corner there is a Valley dropping water along with a downspout placing water onto the back patio. Patio is higher than the top of the foundation wall. It is letting water in along the top surface of this soleplate. The same condition exists across the back. It is causing a lot of water intrusion into this area.

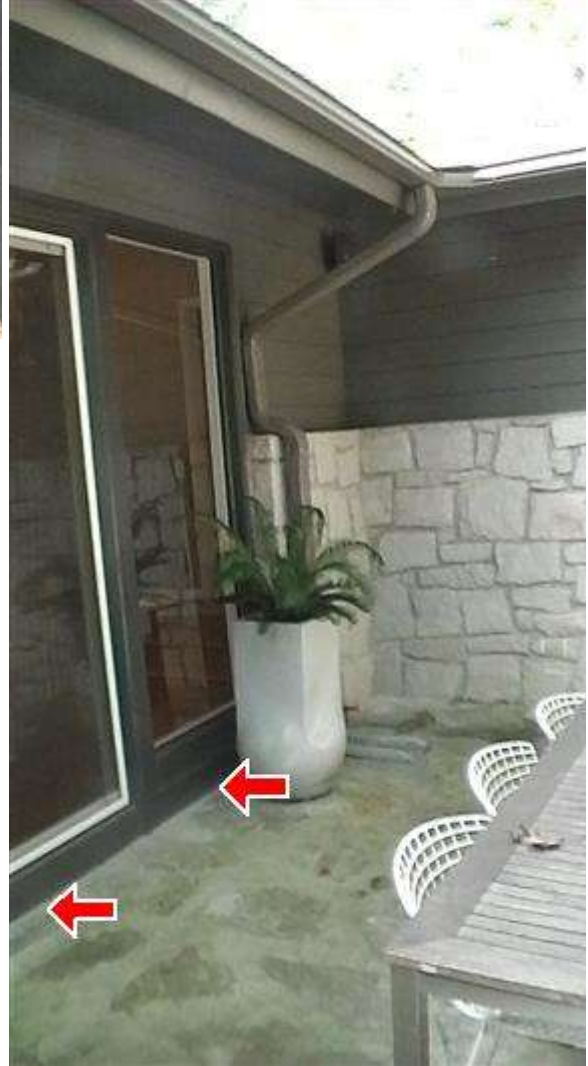
13.3 Picture 7. Exterior patio is higher than the top of the foundation wall

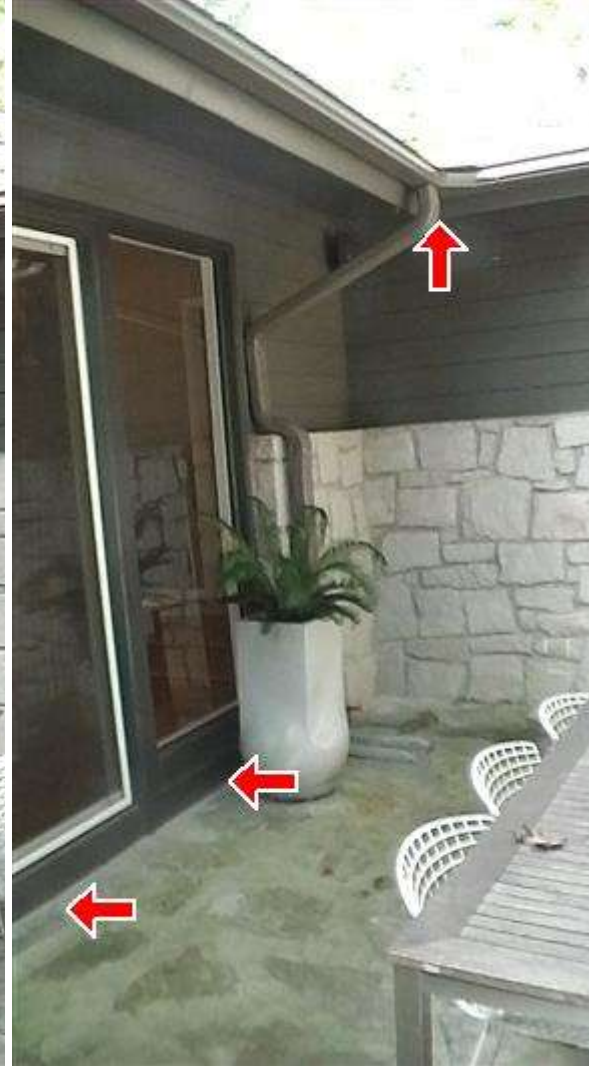
13.3 Picture 9. Water collection area brings water into the crawl

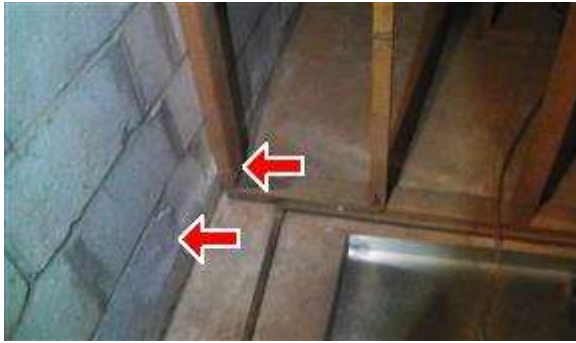
(3) There is efflorescence along the front foundation wall behind the furnace. There is an open drain pipe that will need to be cleared and channeled out to make sure that water is draining out. This is where the overflow from the water heater terminates and there's been some past intrusion and moisture in this area. The drain line will need to be cleared and tested to determine where it ends. There is a possibility of water back up depending on where it terminates.

13.3 Picture 10. Efflorescence

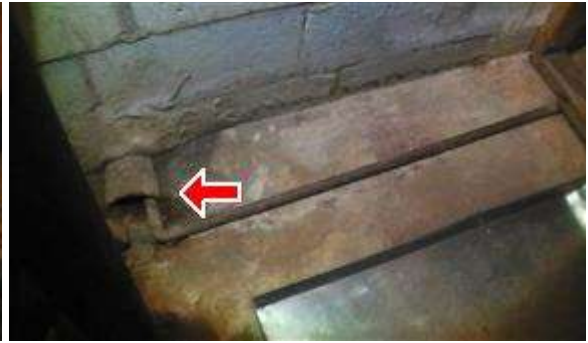
13.3 Picture 11. Drain with moisture signs

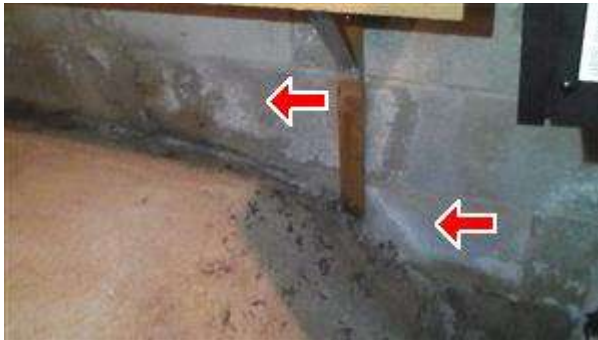
13.3 Picture 14 Efflorescence

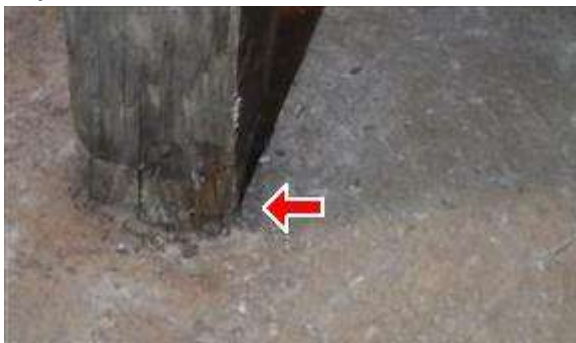
13.5 Picture 1

There are 4 x 4 posts that are used as additional support. These posts are not bracketed into the concrete floor and are capable of shifting. Repair.

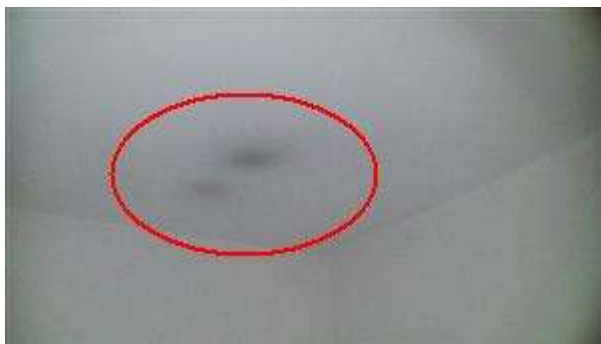
14.2 Picture 1

There are two stains in the bedroom ceiling. Rear right corner that cannot be identified. Ask the seller's. This is in the basement.

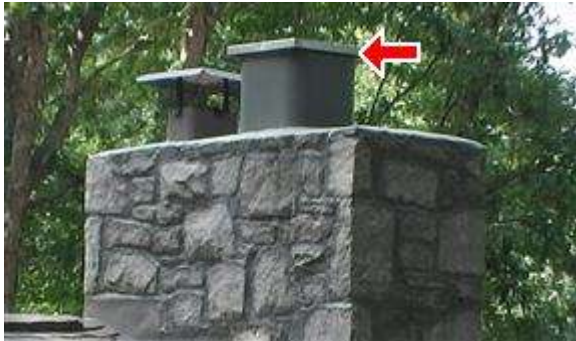
15.1 Picture 1

(2) The main flue vent has a damper in place at the top of the stack. This should be redesigned so that the damper is on the inside of the fireplace. If it is kept outside then build a shroud on top that will protect the opening when the damper is open. This damper is not working correctly and will need to be serviced. The damper control in the walk in fireplace does not open the damper all the way. This is located in the dining room. This is a gas log system. Repair.

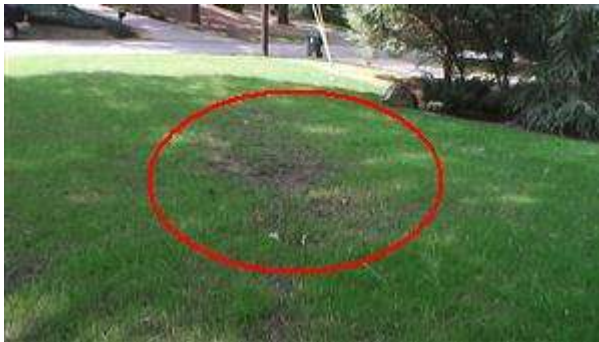
4.5 Picture 1

(2) There is a bare spot in the front yard towards the middle. It looks like this is where there is some moisture build up and possible erosion. Have the sellers identify

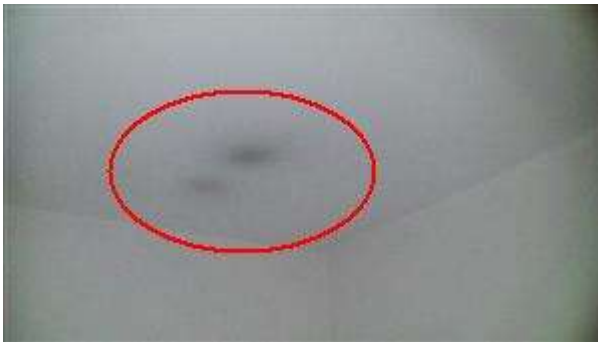
14.2 Picture 1

"M" Minor Repair, "V" Evaluation. Further research required  
There are two stains in the bedroom ceiling. Rear right corner that cannot be identified. Ask the seller's. This is in the basement.

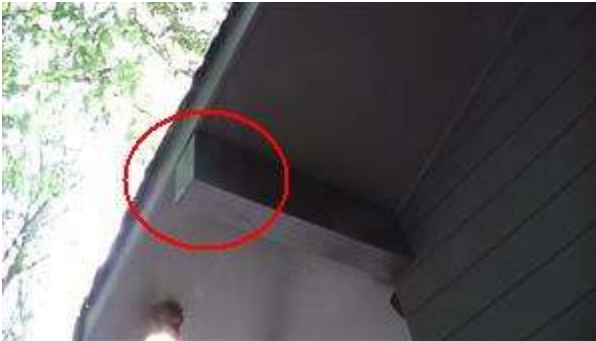
3.3 Picture 3

(2) Repair the wood damage to the beams that extend on the rear right coming off the master bedroom.

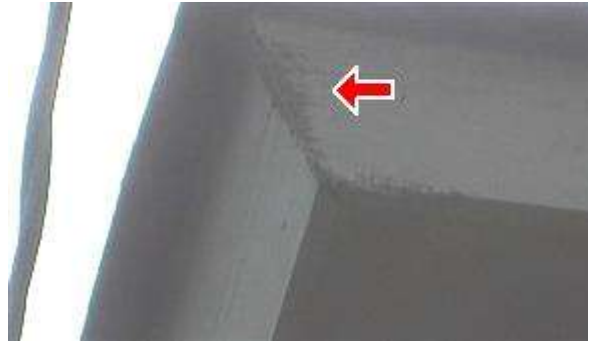
3.3 Picture 5

(3) The fascia board at the front left corner has wood rot damage. Repair.

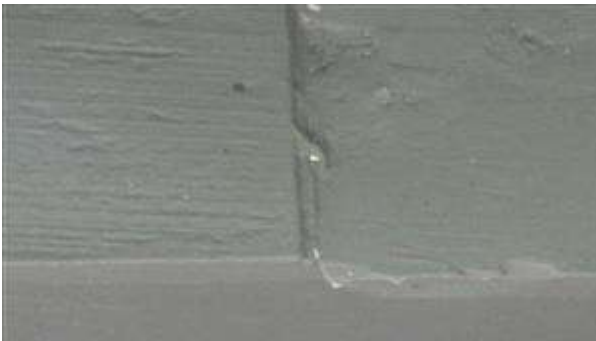
3.3 Picture 6

(4) Fascia board at the right side just behind the gutter system is damaged and the board should be replaced.

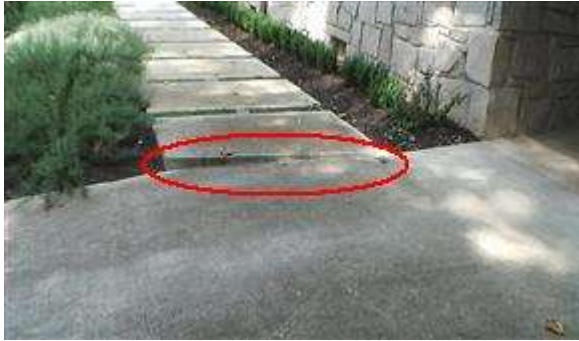
4.4 Picture 1

The way the stone walkway is tied into the driveway at the front represents a trip hazard. This should be leveled.

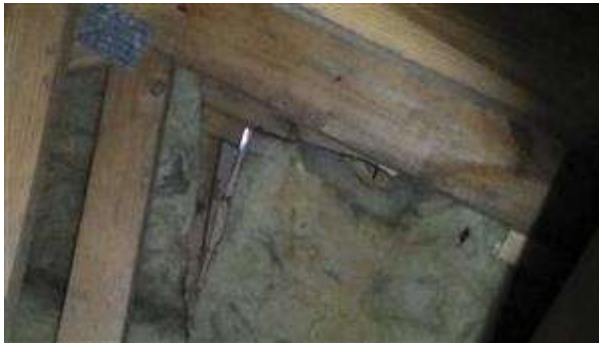
7.2 Picture 1

Insulation is approximately an R5. Bring this up to a minimum of an R30. Insulation along the knee wall is pretty low and it will need to be increased.

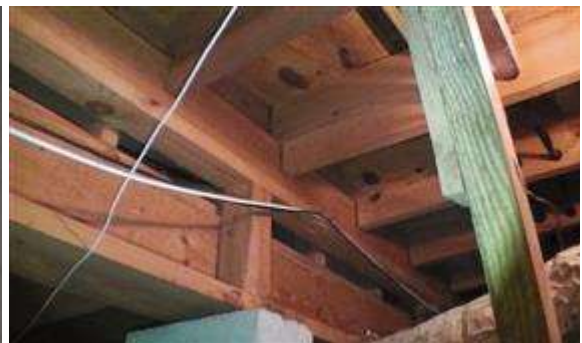
13.2 Picture 4 Need insulation under the floor

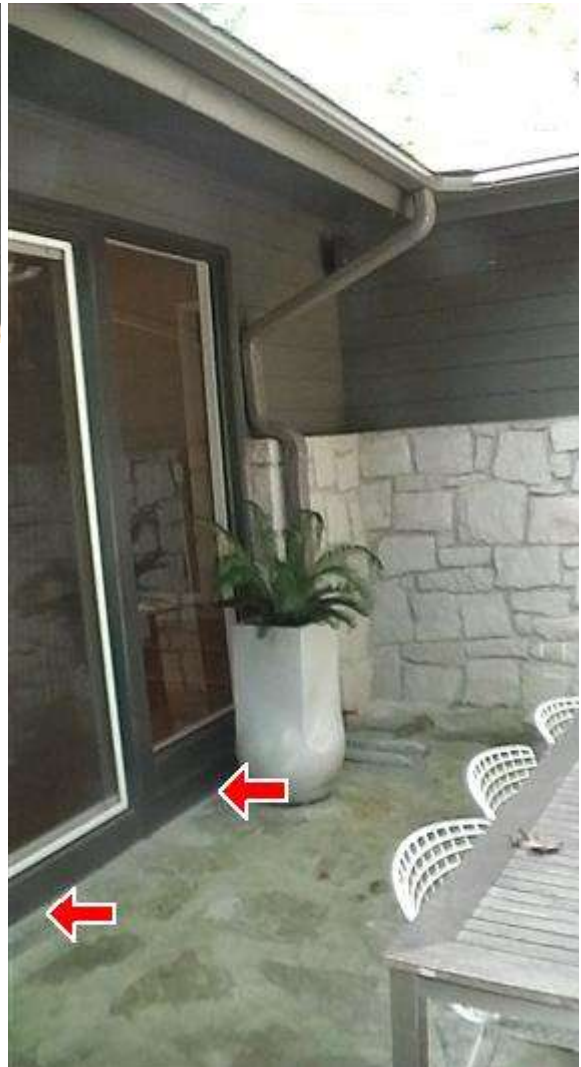
13.3 Picture 7. Exterior patio is higher than the top of the foundation wall

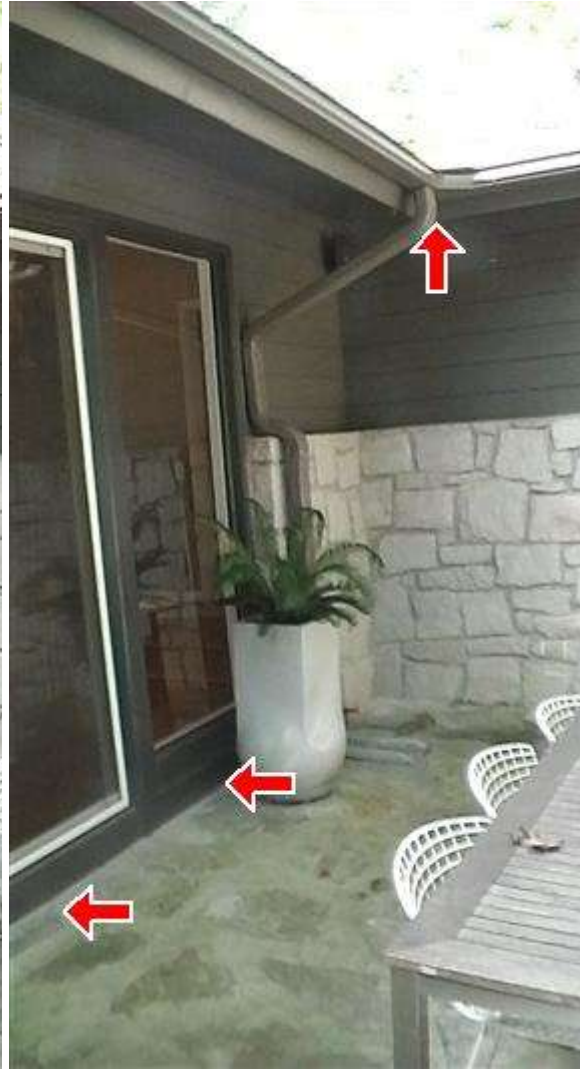
13.3 Picture 9. Water collection area brings water into the crawl

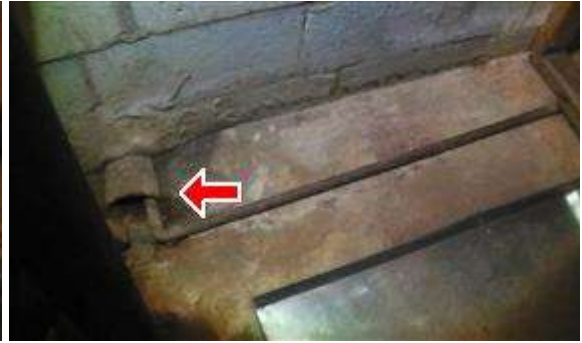
(3) There is efflorescence along the front foundation wall behind the furnace. There is an open drain pipe that will need to be cleared and channeled out to make sure that water is draining out. This is where the overflow from the water heater terminates and there's been some past intrusion and moisture in this area. The drain line will need to be cleared and tested to determine where it ends. There is a possibility of water back up depending on where it terminates.

13.3 Picture 11. Drain with moisture signs

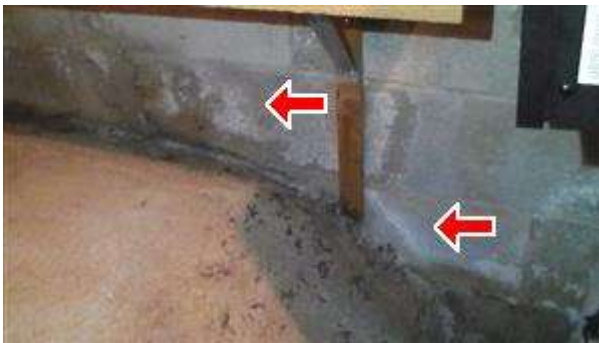
13.3 Picture 14 Efflorescence

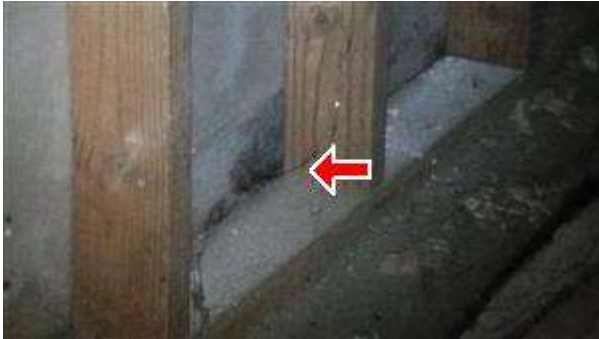
13.4 Picture 1

(1) In the crawl space to the rear left corner. There is an open area under a built up wall and there are spores growing along the base. There's been some water intrusion in this area. It is currently dry. Mitigate.

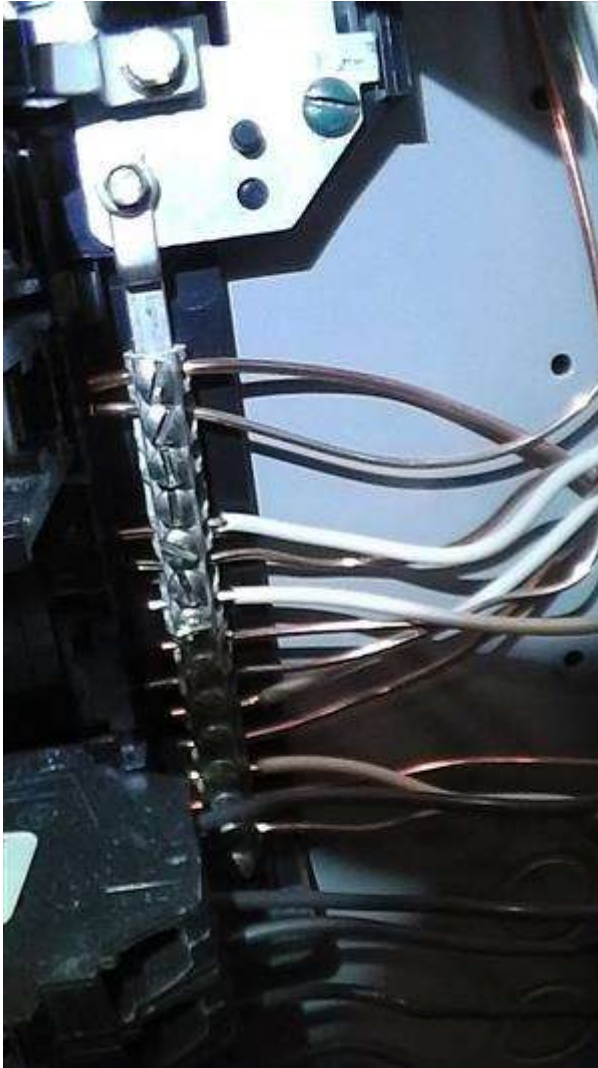
10.3 Picture 1

(2) The electrical panel box is not grounded. Repair. The neutrals and the grounds are combined.

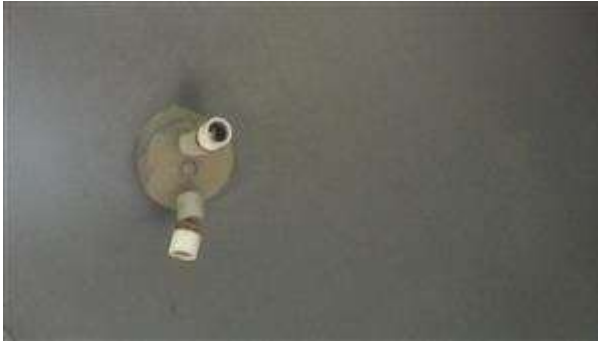
10.5 Picture 1

The exterior floodlights are missing on the front left corner. Add.

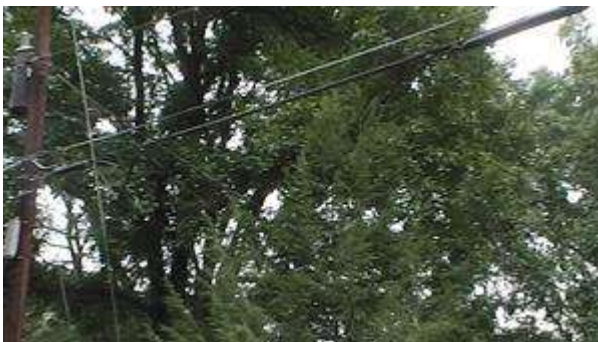
10.7 Picture 1

Overhead lines from the street need to be kept clear of branches. Need the power company to clear the branches around the lines.

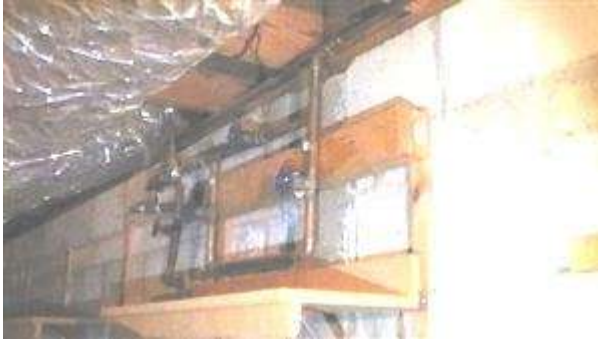
11.6 Picture 1

(1) The main incoming water line is copper coming through the wall. It is at the front of the house in the crawl space and the pressure regulator valve is located here as well. Need to add bonding around the pressure regulator valve.

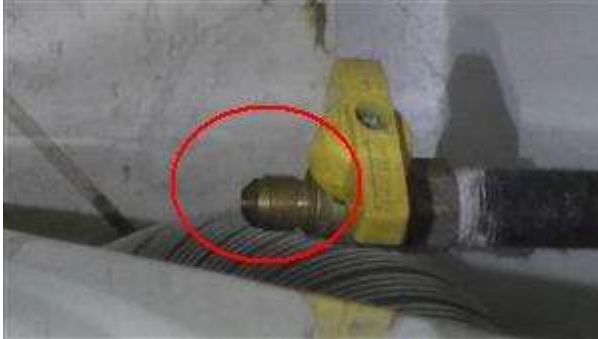
11.3 Picture 1

Cap the gas line in the laundry room. .

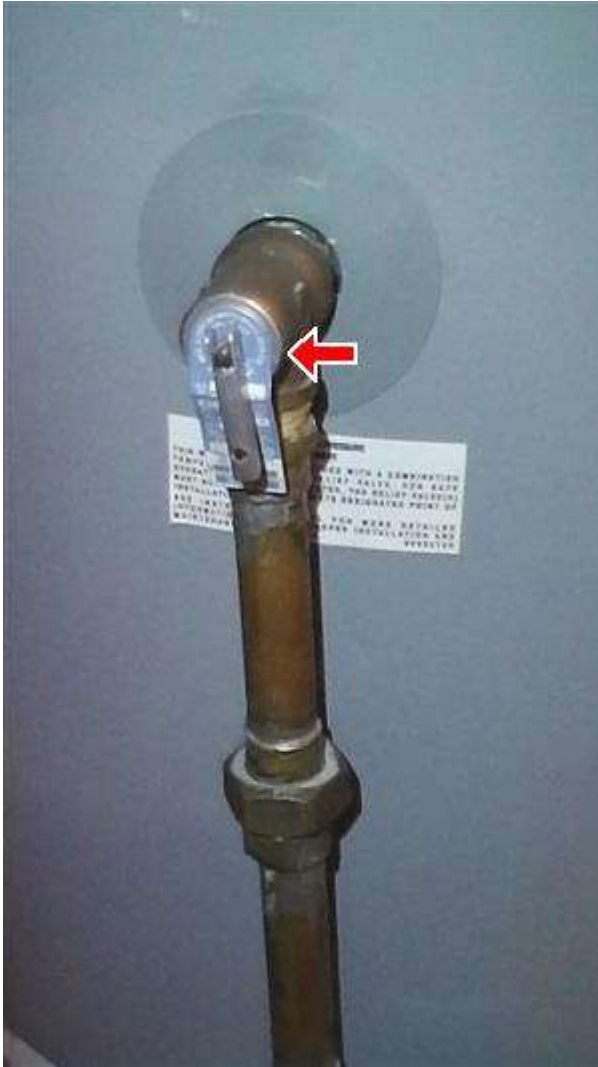
11.7 Picture 1

you experience leaking or a seized condition. (V),  
(M), (FYI)

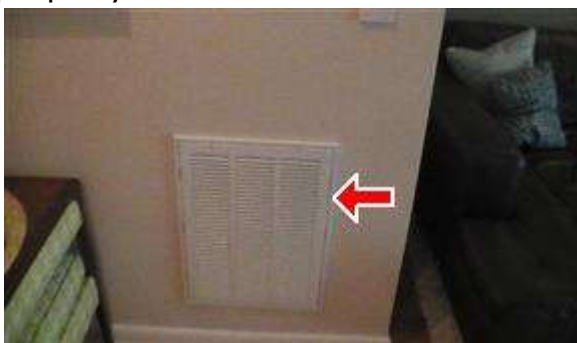
8.3 Picture 1

(2) The filter in the basement is on the return side. It needs to be properly fastened inside the return vent.

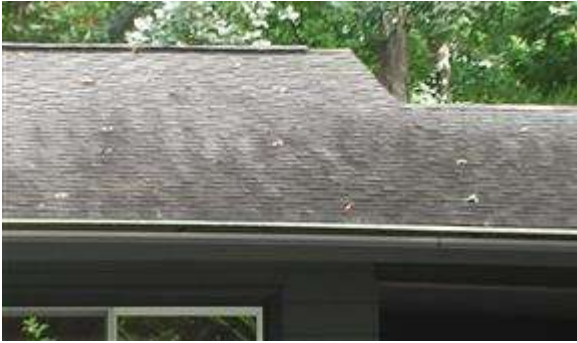
3.2 Picture 1. full cleaning and service required

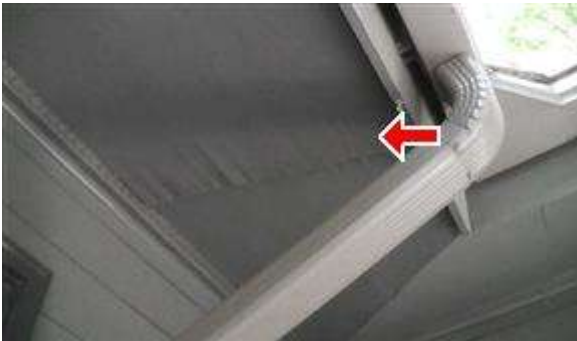
3.3 Picture 1

(1) On the rear left corner where the Valley is there soffit delamination that will need to be repaired. This is just as you walk out from the family room door.

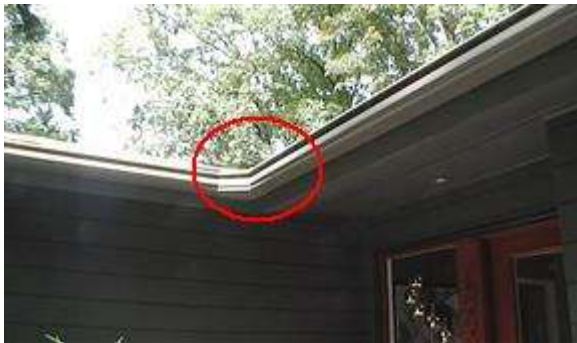
3.5 Picture 1

Valley guard should be installed at the front Valley to the entrance of the house. Front entrance is a protected area. Water spills over top of the Valley termination onto the front stoop during heavy rains.
