# Inspection Report

1060 Trail

Atlanta Georgia 30328

**Inspectors Associates, Inc.**

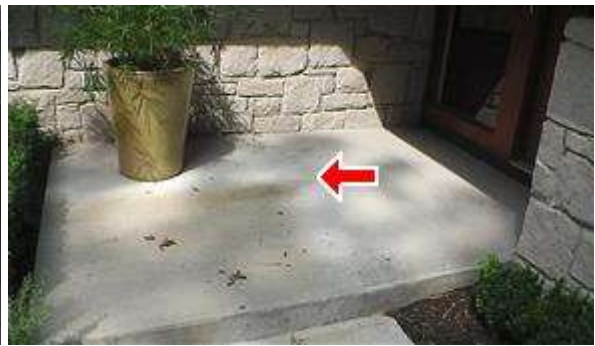
3.5 Picture 2. Water currently spills over the valley at the front entrance

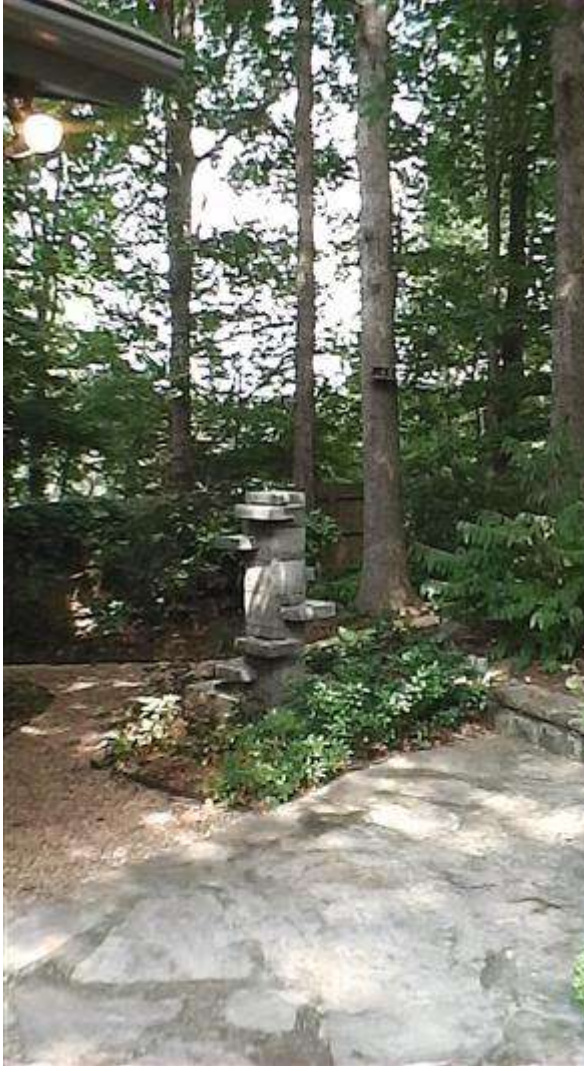
4.0 Picture 1. will this stay with the sale

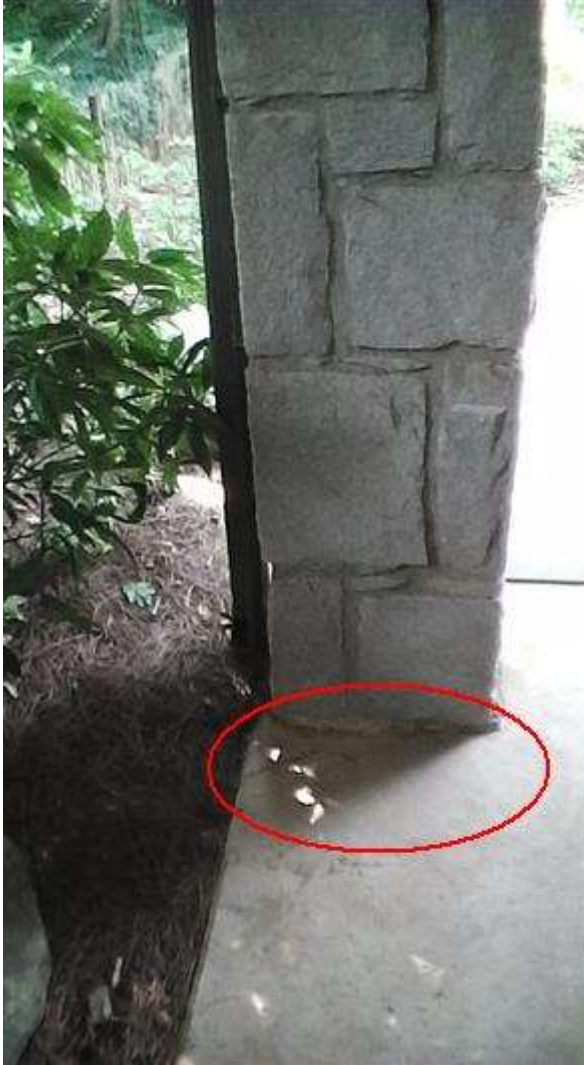
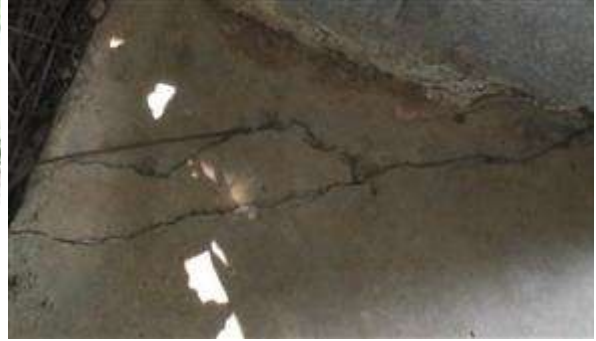
- 1 Comments: "MO" Monitor. This must be watched., For Your Information  
(1) The front right pillar supporting the roof of the carport has some settlement around the base of the pillar. This is a stone pillar. Monitor for any change.

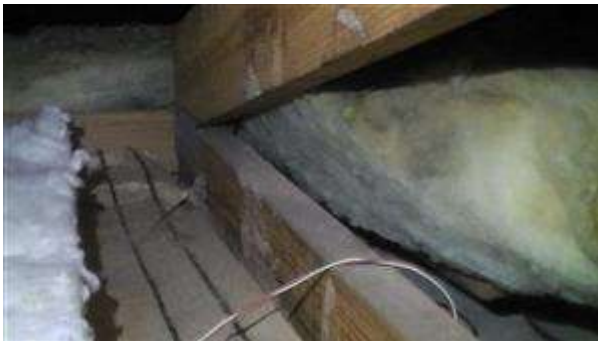
7.4 Picture 1

There are spores on the wood work in the attic. This is typical to find in an attic space. There is no HVAC system pulling this air into the house. Monitor.

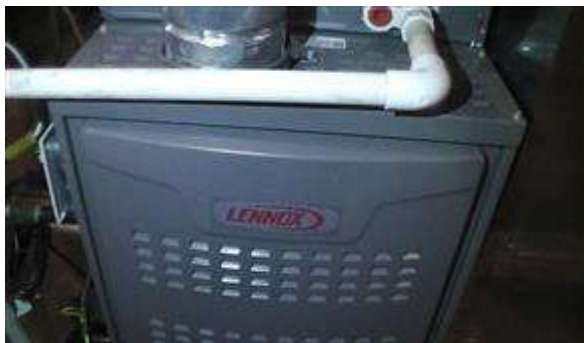
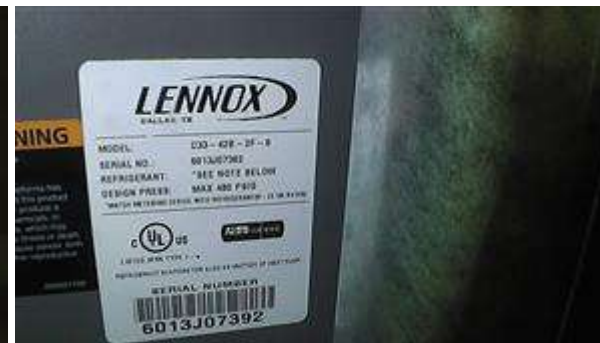
The unit in the crawl space is manufactured by Lennox. Manufactured in 2013. This is an 88000 BTU unit. Filter is accessed from the exterior.

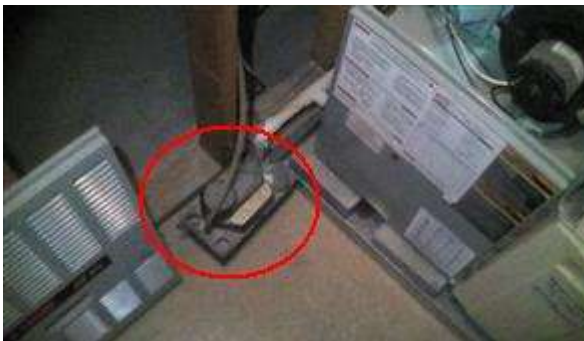
8.2 Picture 3. Place into a drip pan

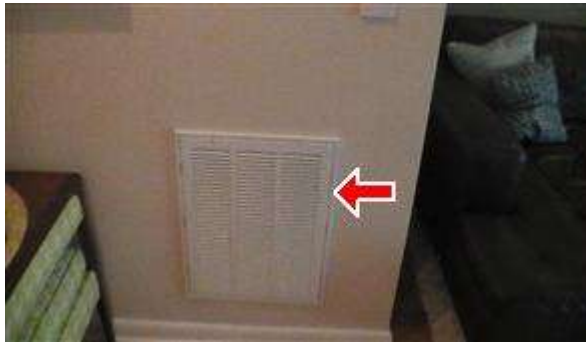
8.3 Picture 1

(2) The filter in the basement is on the return side. It needs to be properly fastened inside the return vent.

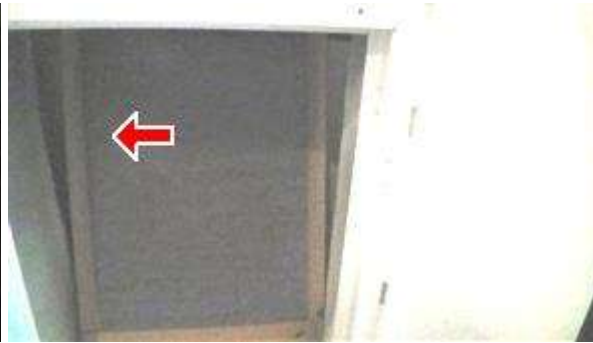
8.3 Picture 2. Not set into place correctly

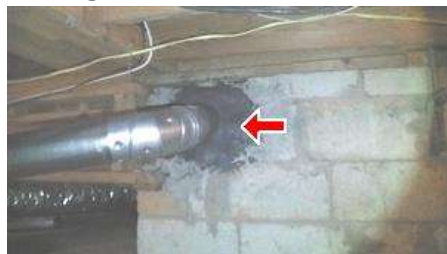
8.4 Picture 1

The flue vent exits the stack from the crawl space. This will need to be evaluated to make sure there is a protected exit of the gas fumes through the stack.

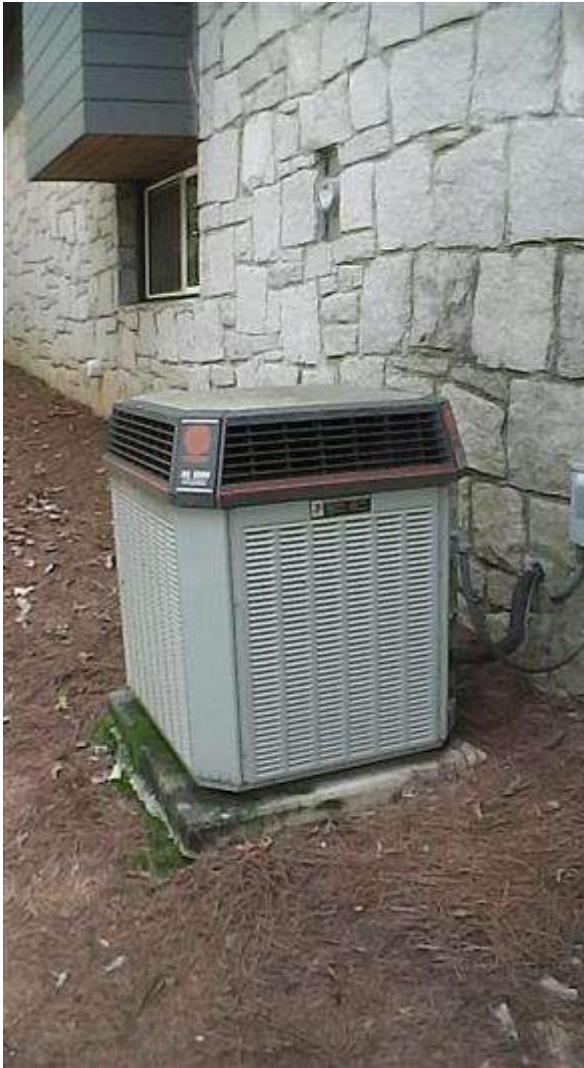
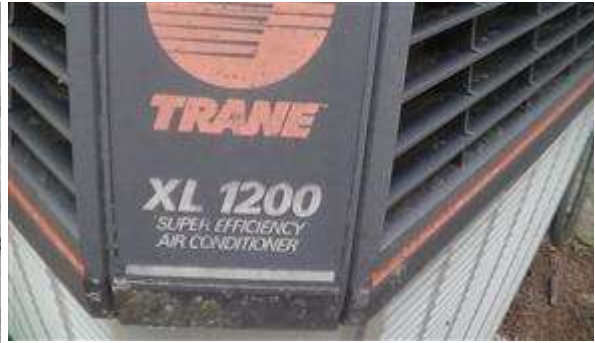
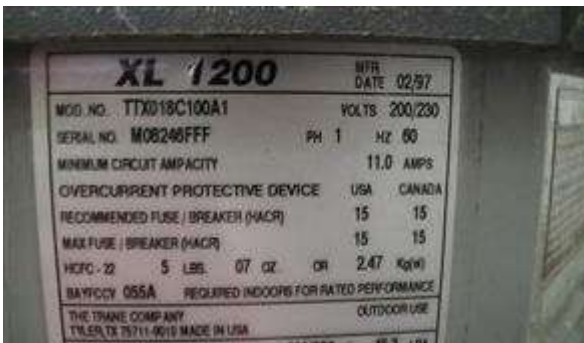
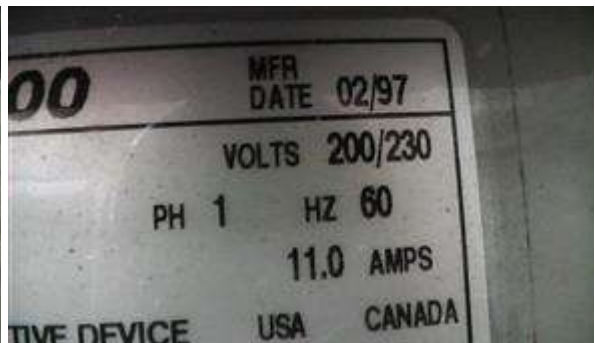
(1) Trane XL 200 manufactured in 1997. It is a 1.5 ton unit and takes a 15 amp breaker. This is the unit closest to the rear of the house. This unit uses the old R22 freon which is being phased out of existence and is very expensive to purchase. Anticipate that you will need to change out this system in the near future. This unit is 16 years old and reaching the end of its life span.

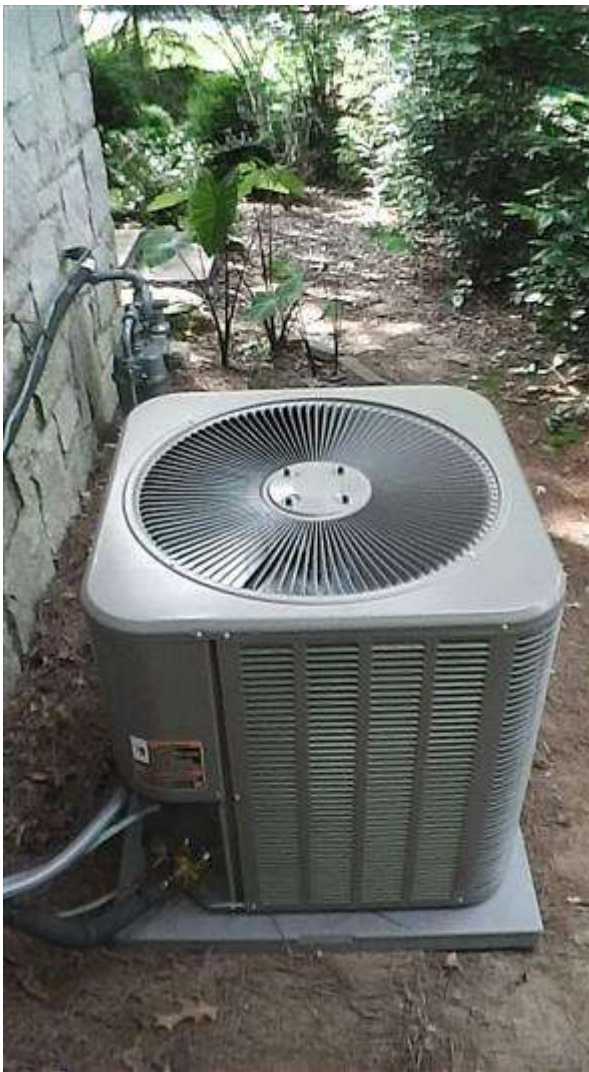
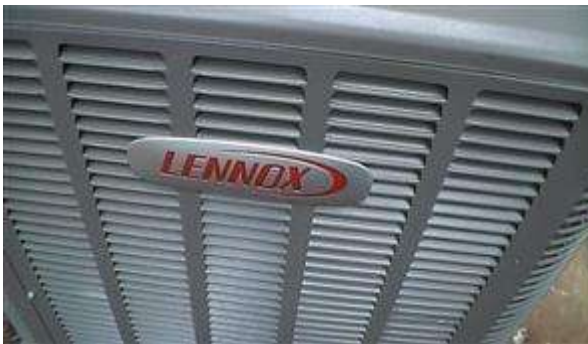
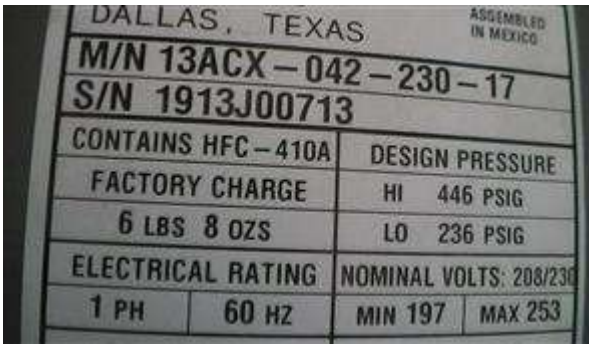
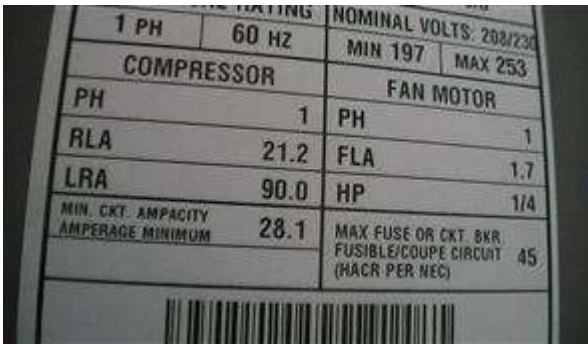
(2) Lennox manufactured in 2013 is a 3.5 ton unit. This takes a 45 amp breaker. This unit was installed the day before the inspection. This takes the new 410 Freon.

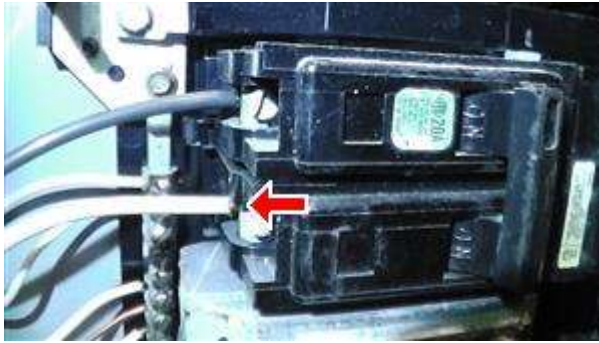
10.4 Picture 1

(1) There is a main panel and a sub panel. The breakers are not labeled. Label the breakers.

(2) In the GE panel box. There is a white wire that. Is used as a hot feet and it needs to be properly identified.

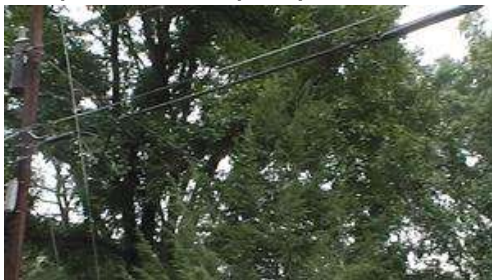
10.7 Picture 1

Overhead lines from the street need to be kept clear of branches. Need the power company to clear the branches around the lines.

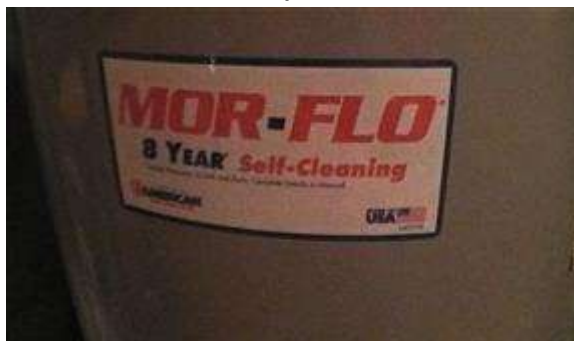
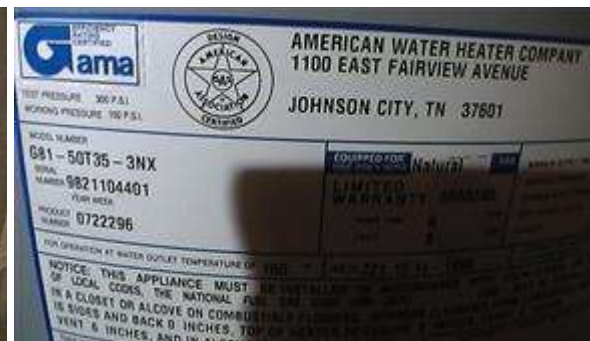
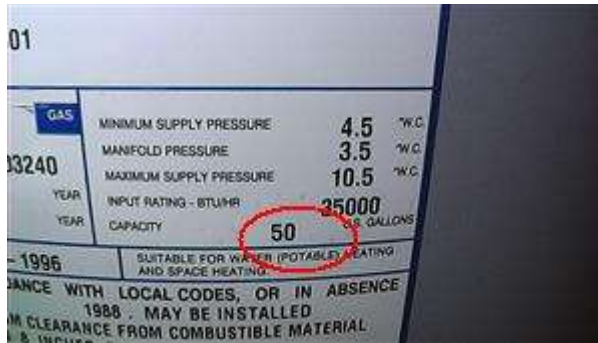
Water heater is manufactured by Mor Flo. It is located in the crawl space. Manufactured in 2007. This is a 50 gallon tank. This is 6 years old. Missing an expansion tank that will need to be installed when the water heater is replaced.

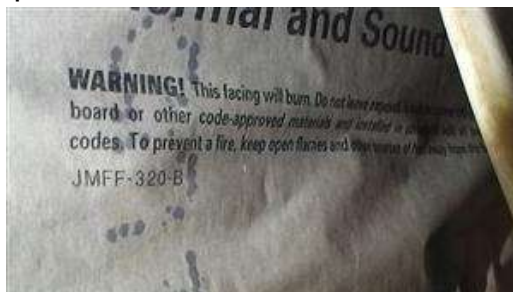
The insulation on the wall between the crawl space in the main living space has paper backing and it is exposed. This is labeled as a fire hazard and will need to be dealt with. The entire wall is not fully insulated. Repair. There is no insulation on the ceiling of the crawl space of the attic. All this will need to be corrected.

13.2 Picture 1. exposed paper is a fire hazard

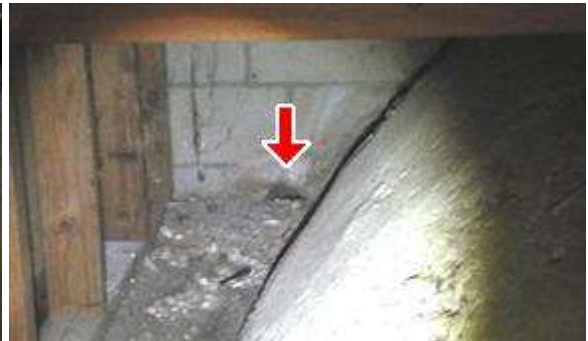
13.3 Picture 2

(1) Underneath this rear left corner in the crawl space at the bottom of the foundation wall there is a drain opening. I do not know where it terminates. It should be tested and evaluated. Currently there are some loose stones blocking the drain. Clear and evaluate. All drains of this kind should have a back flow preventer to avoid water intrusion into the interior.

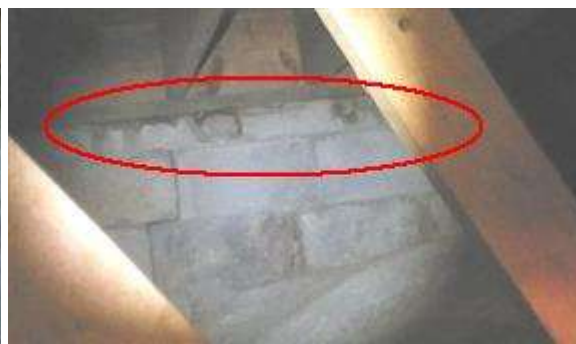
13.3 Picture 5

(2) Along the rear block wall at the sole plate there are water stains. This intrusion comes from the exterior due to the patio being higher than the top of the foundation wall. The patio should be lowered or provisions made to install a drainage system to capture the water below the top of the foundation wall on the outside patio

Where there's a lot of water in the inside crawl corner there is a Valley dropping water along with a downspout placing water onto the back patio. Patio is higher than the top of the foundation wall. It is letting water in along the top surface of this soleplate. The same condition exists across the back. It is causing a lot of water intrusion into this area.

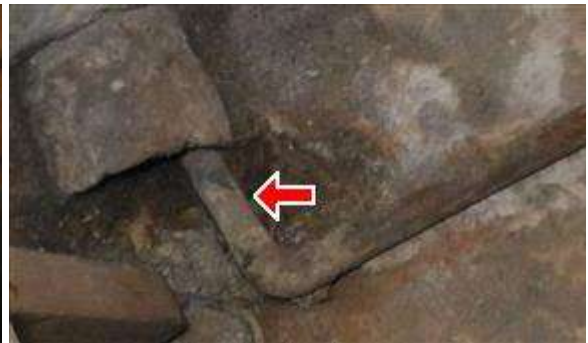
(3) There is efflorescence along the front foundation wall behind the furnace. There is an open drain pipe that will need to be cleared and channeled out to make sure that water is draining out. This is where the overflow from the water heater terminates and there's been some past intrusion and moisture in this area. The drain line will need to be cleared and tested to determine where it ends. There is a possibility of water back up depending on where it terminates.

13.3 Picture 13. T&P drain line termination

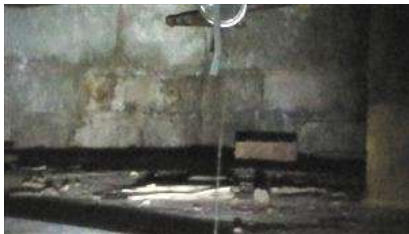
13.3 Picture 15

(4) The rear right corner foundation wall has been taking in water and there are signs of spores in this area. Repair.

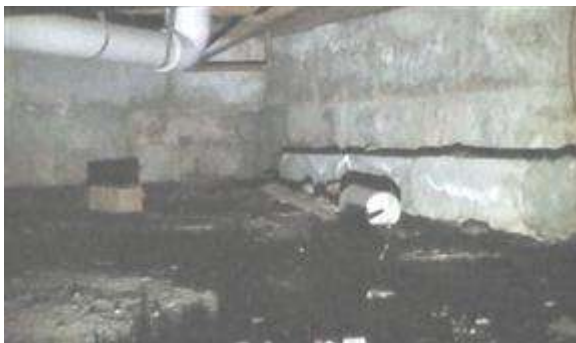
13.3 Picture 17. Entry point for water

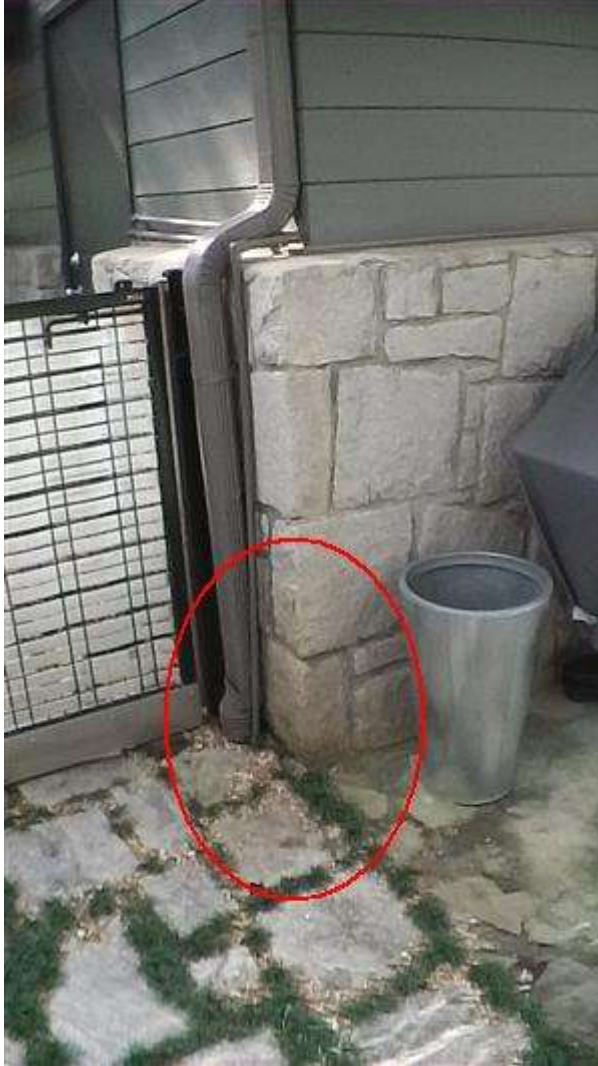
13.3 Picture 19 From the outside this is what we are dealing with

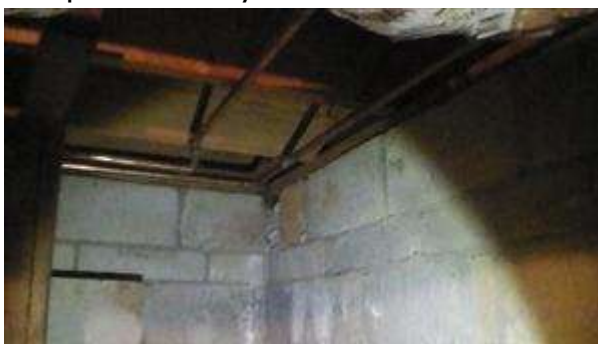
13.3 Picture 20

(5) Front right corner has dampness and water intrusion. Everything needs to be controlled from the exterior roof through the downspouts and pulled away from the house.

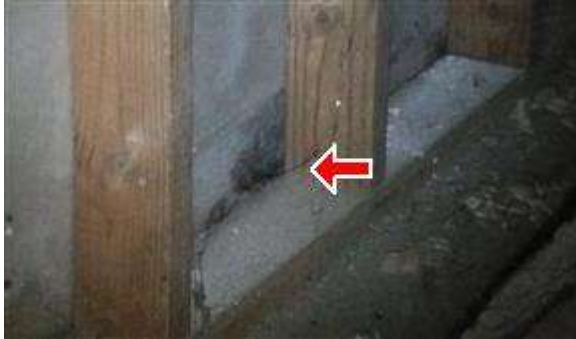
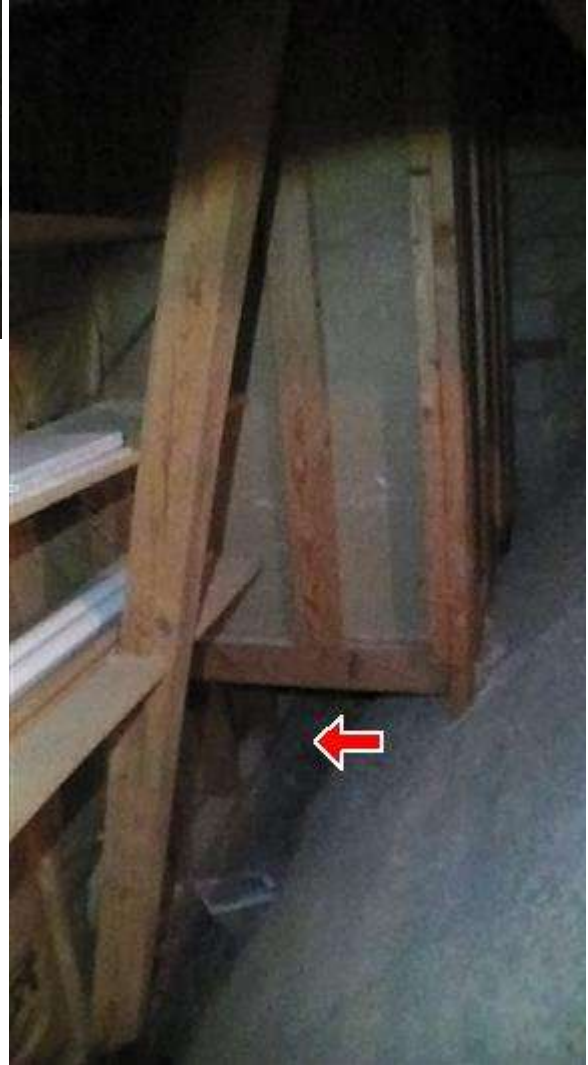
(1) In the crawl space to the rear left corner. There is an open area under a built up wall and there are spores growing along the base. There's been some water intrusion in this area. It is currently dry. Mitigate.

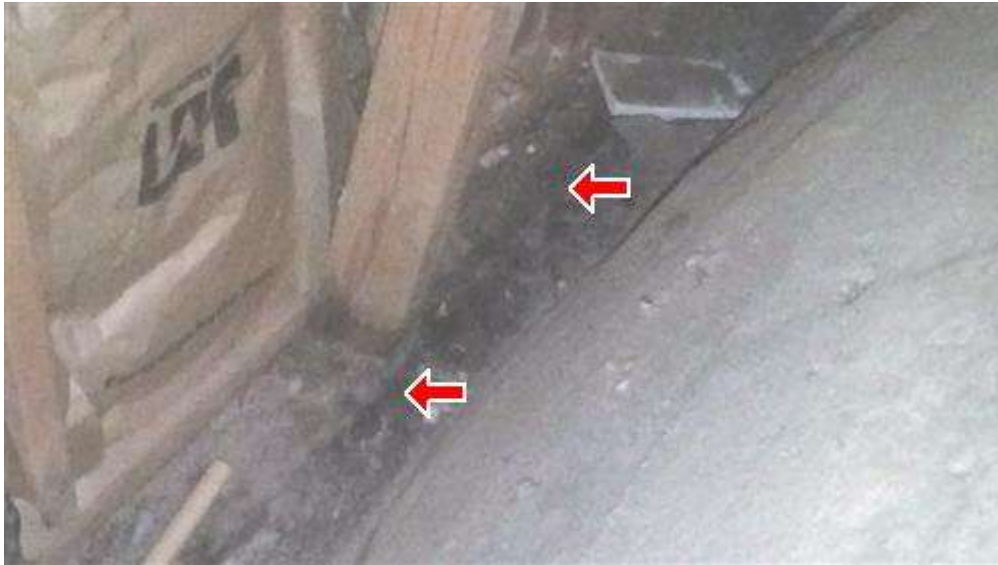
13.4 Picture 3 water intrusion area

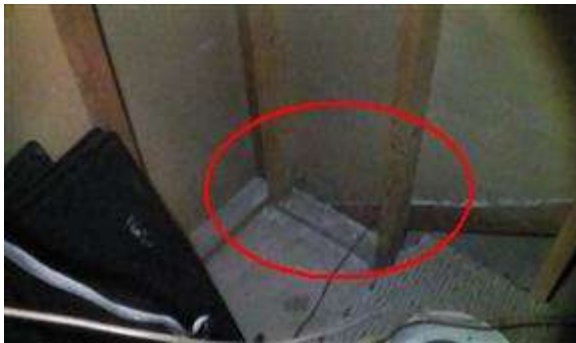
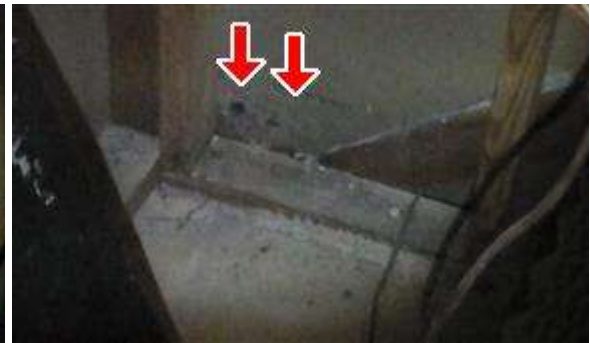
(2) Behind the electrical panel boxes at the bottom of the stairs are some spores that will need to be mitigated.

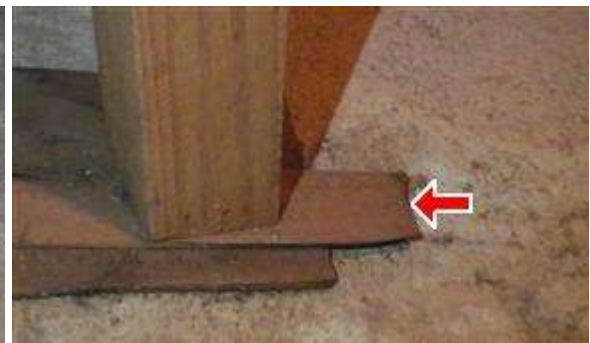
13.5 Picture 2

There are 4 x 4 posts that are used as additional support. These posts are not bracketed into the concrete floor and are capable of shifting. Repair.

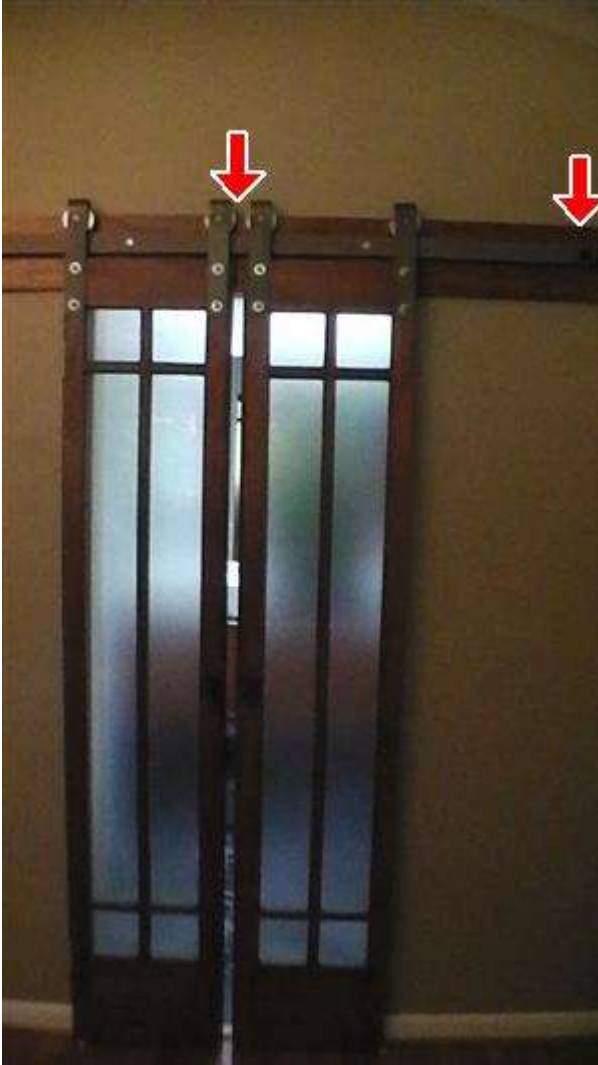
14.3 Picture 1

(2) Stops on the sliding double doors leading into the master bathroom from the master bedroom and are needed.

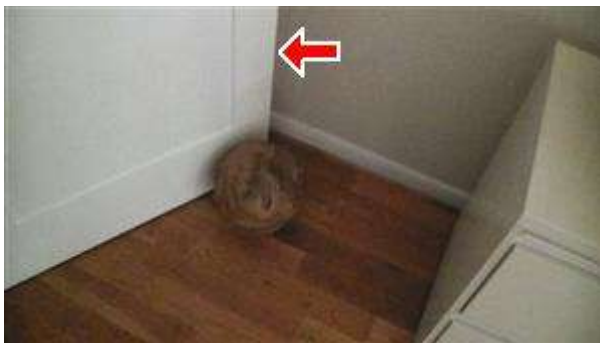
14.3 Picture 2

(3) The door to the front bedroom drifts. Adjust.

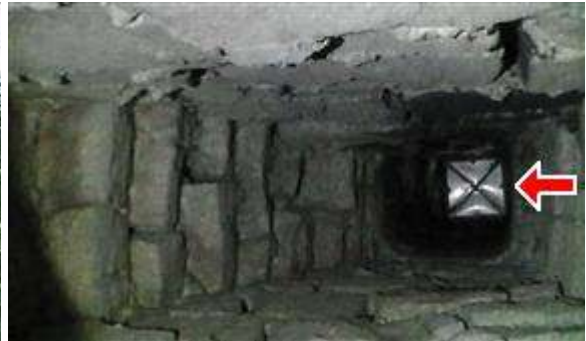
15.1 Picture 2

(2) The main flue vent has a damper in place at the top of the stack. This should be redesigned so that the damper is on the inside of the fireplace. If it is kept outside then build a shroud on top that will protect the opening when the damper is open. This damper is not working correctly and will need to be serviced. The damper control in the walk in fireplace does not open the damper all the way. This is located in the dining room. This is a gas log system. Repair.

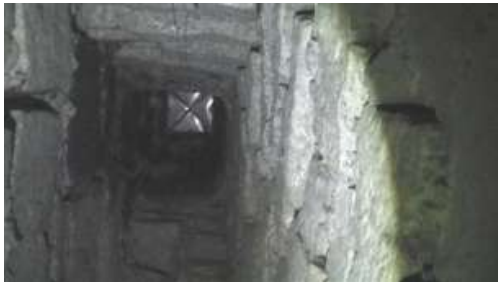
15.1 Picture 3. Not lined and can be a problem

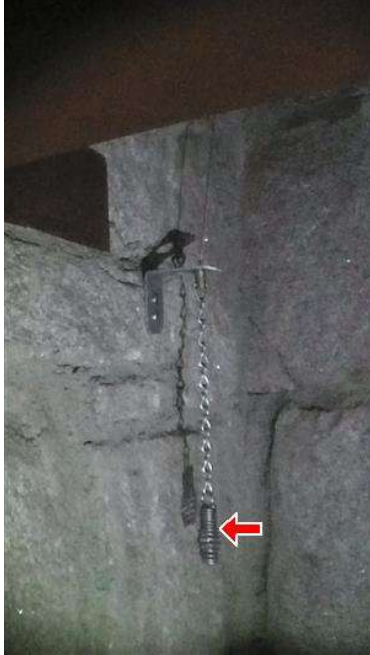
15.1 Picture 4. Current damper control

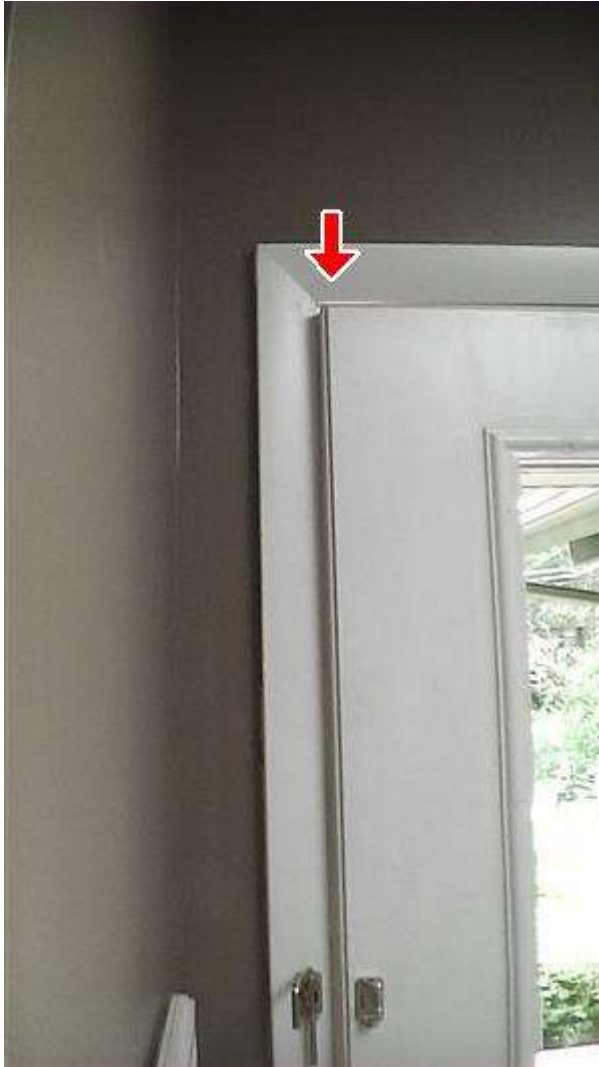
4.2 Picture 1

(1) The front door needs to be adjusted. It is binding at the top corner latching side.

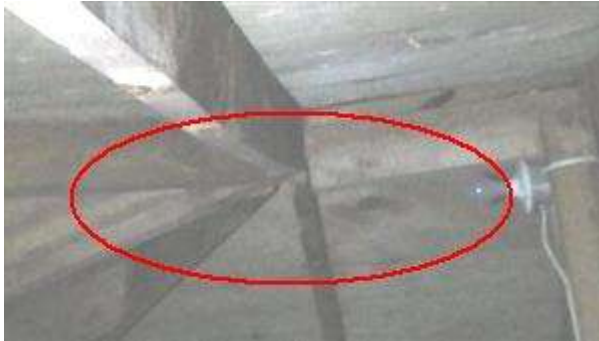
7.5 Picture 1

The ridge to hip connection on this roofline needs bracing and support. This is directly behind the pull down attic space entrance.

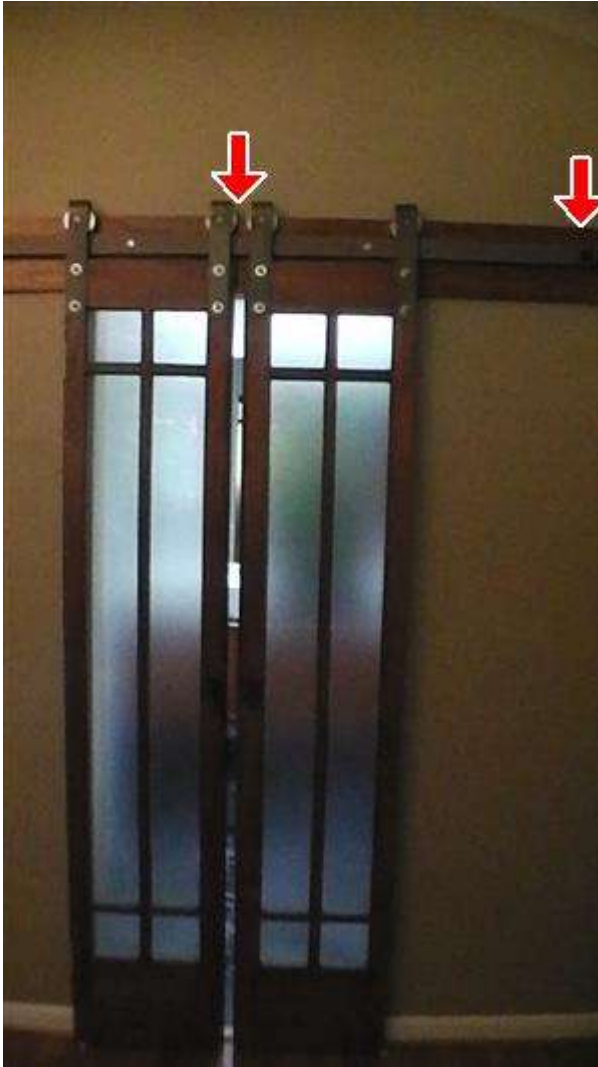
14.3 Picture 1

(2) Stops on the sliding double doors leading into the master bathroom from the master bedroom and are needed.

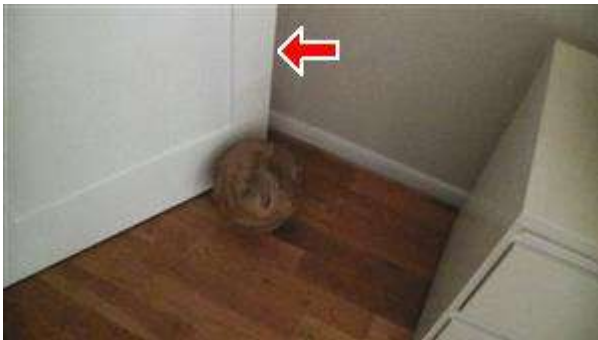
14.3 Picture 2

(3) The door to the front bedroom drifts. Adjust.

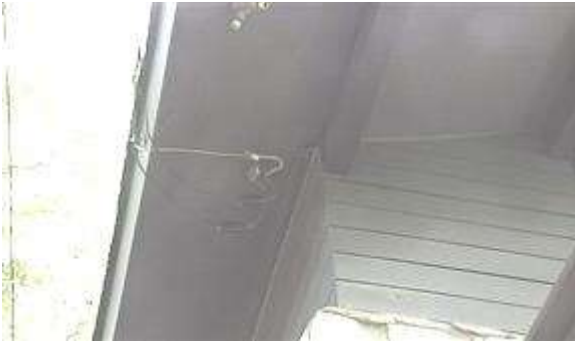
3.3 Picture 4

(3) The fascia board at the front left corner has wood rot damage. Repair.

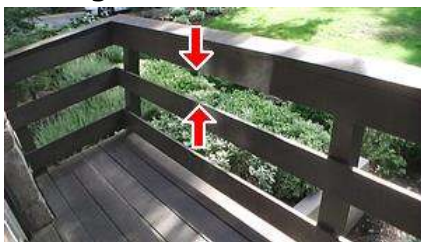
6.1 Picture 1

The balcony railing system off the front bedroom left side is greater than 4 inches on center and needs to be redone to reduce all openings to no greater than 4 inches.

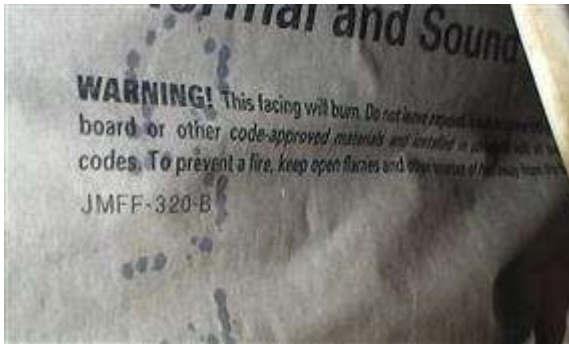
The insulation on the wall between the crawl space in the main living space has paper backing and it is exposed. This is labeled as a fire hazard and will need to be dealt with. The entire wall is not fully insulated. Repair. There is no insulation on the ceiling of the crawl space of the attic. All this will need to be corrected.

13.2 Picture 1. exposed paper is a fire hazard

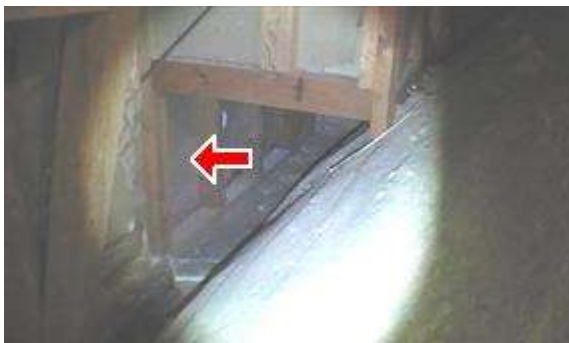
13.2 Picture 3 missing insulation

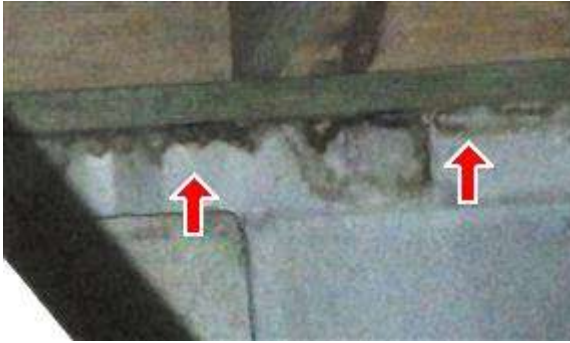
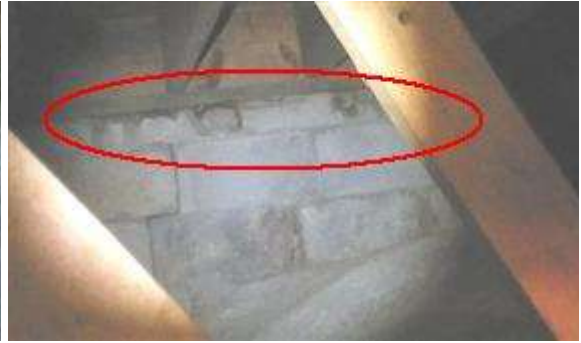
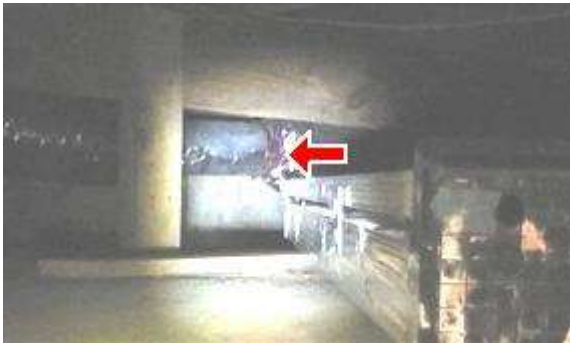
13.3 Picture 4

(2) Along the rear block wall at the sole plate there are water stains. This intrusion comes from the exterior due to the patio being higher than the top of the foundation wall. The patio should be lowered or provisions made to install a drainage system to capture the water below the top of the foundation wall on the outside patio

Where there's a lot of water in the inside crawl corner there is a Valley dropping water along with a downspout placing water onto the back patio. Patio is higher than the top of the foundation wall. It is letting water in along the top surface of this soleplate. The same condition exists across the back. It is causing a lot of water intrusion into this area.

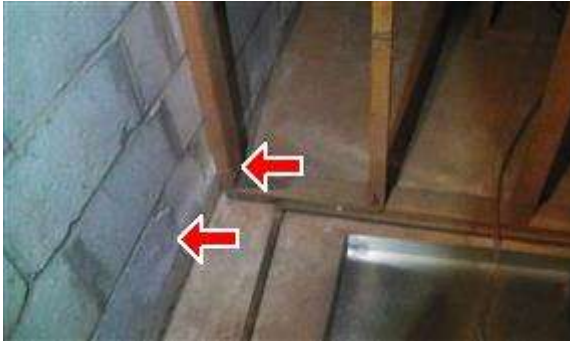
(3) There is efflorescence along the front foundation wall behind the furnace. There is an open drain pipe that will need to be cleared and channeled out to make sure that water is draining out. This is where the overflow from the water heater terminates and there's been some past intrusion and moisture in this area. The drain line will need to be cleared and tested to determine where it ends. There is a possibility of water back up depending on where it terminates.

13.3 Picture 10. Efflorescence

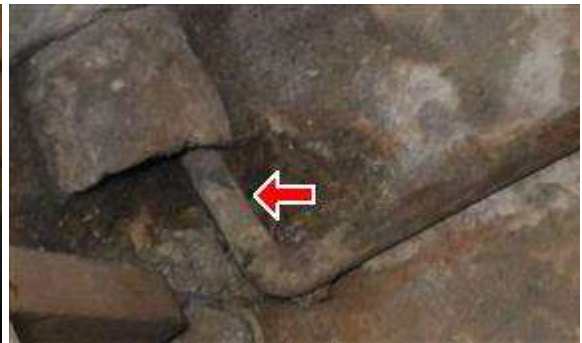
13.3 Picture 13. T&P drain line termination

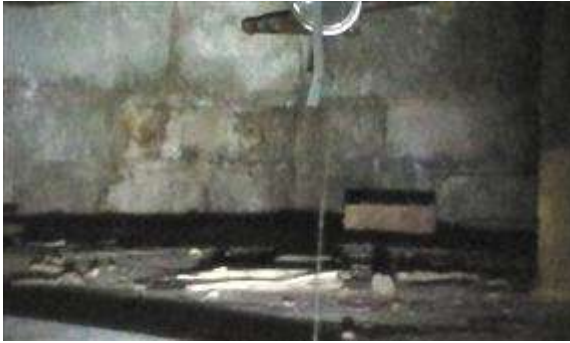
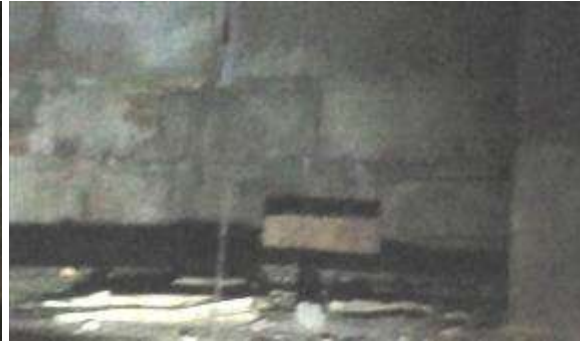
13.3 Picture 15

(4) The rear right corner foundation wall has been taking in water and there are signs of spores in this area. Repair.

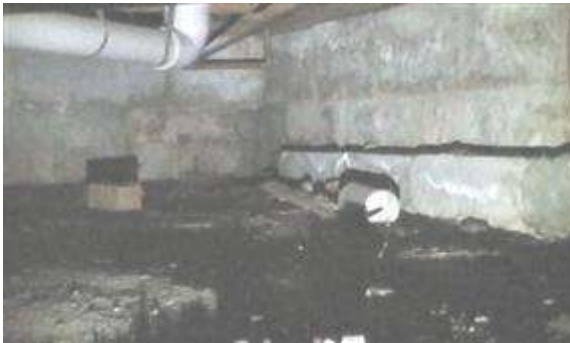
13.3 Picture 17. Entry point for water

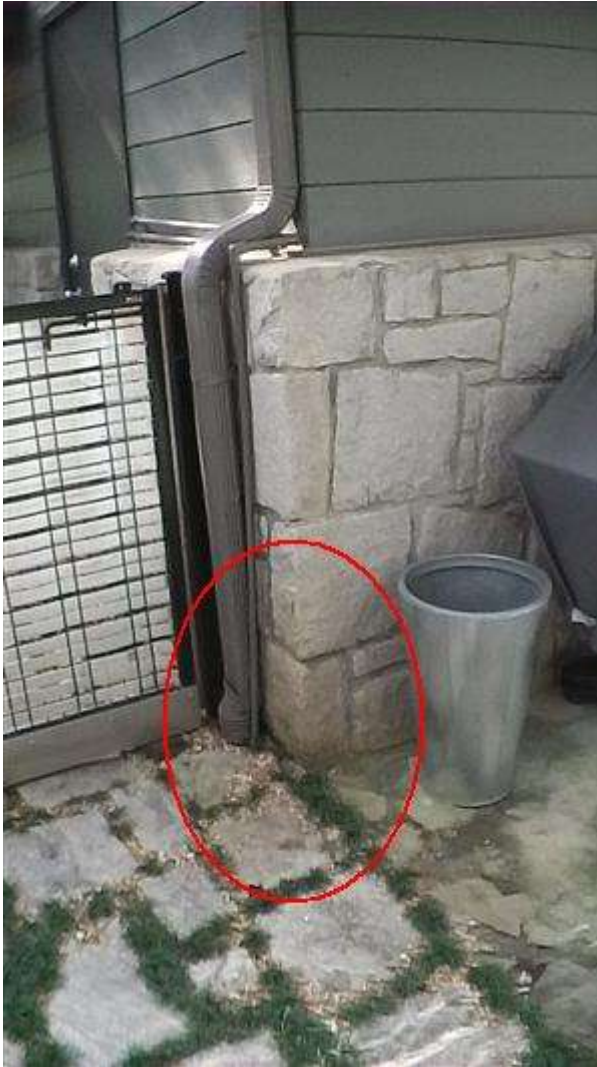
13.3 Picture 19 From the outside this is what we are dealing with

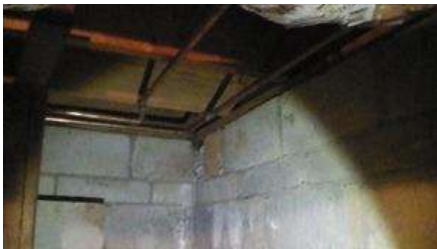
13.3 Picture 20

(5) Front right corner has dampness and water intrusion. Everything needs to be controlled from the exterior roof through the downspouts and pulled away from the house.

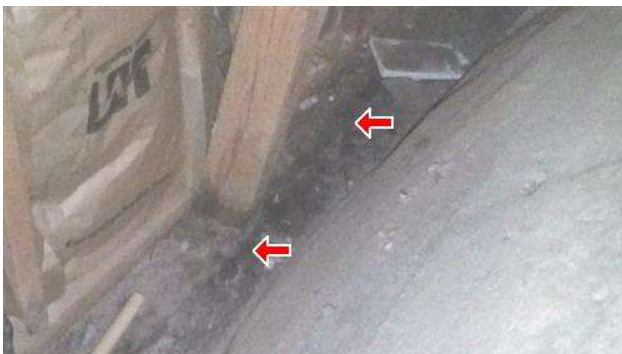
13.4 Picture 3 water intrusion area

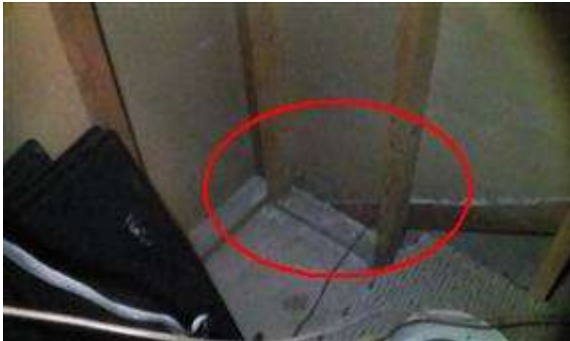
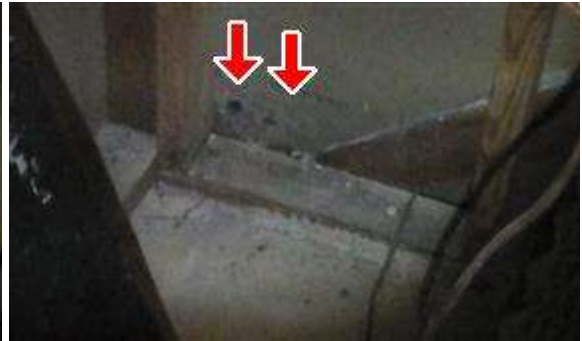
13.4 Picture 4

(2) Behind the electrical panel boxes at the bottom of the stairs are some spores that will need to be mitigated.

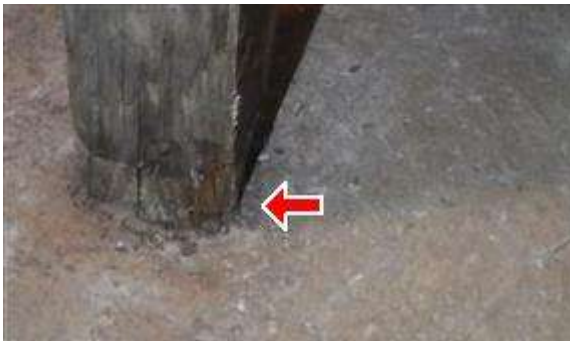
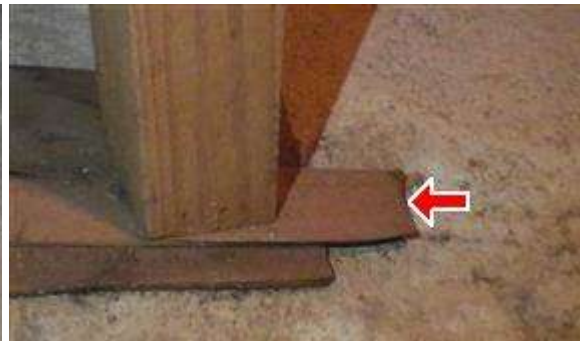
13.5 Picture 1

There are 4 x 4 posts that are used as additional support. These posts are not bracketed into the concrete floor and are capable of shifting. Repair.

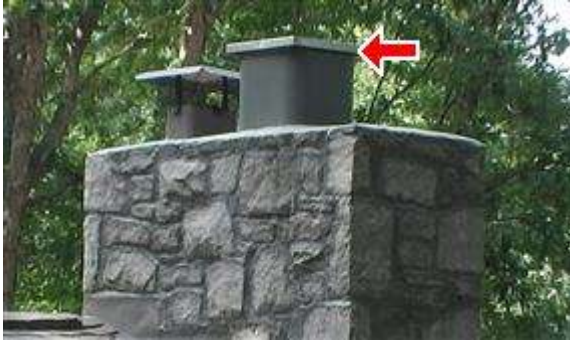
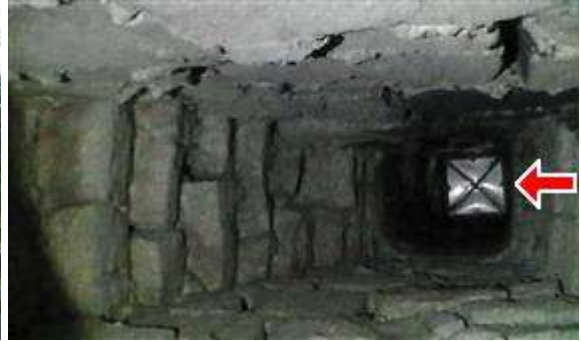
15.1 Picture 1

working correctly and will need to be serviced. The damper control in the walk in fireplace does not open the damper all the way. This is located in the dining room. This is a gas log system. Repair.

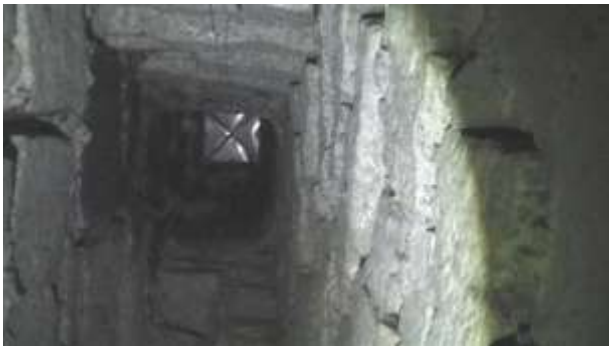
15.1 Picture 3. Not lined and can be a problem

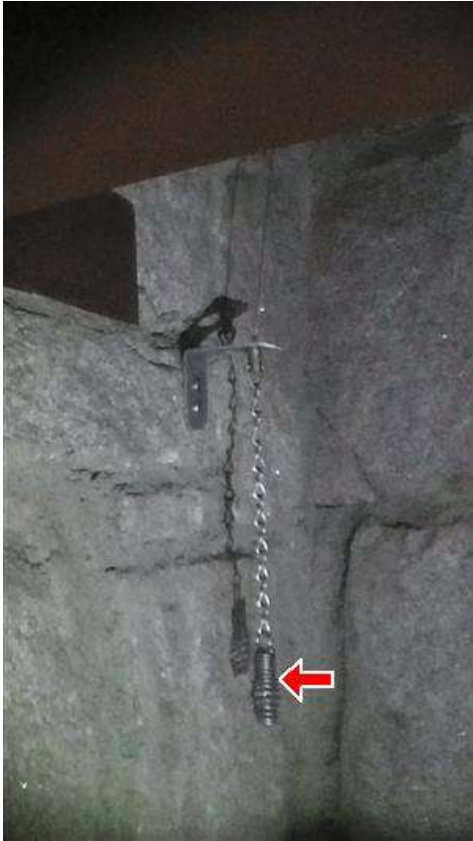
15.1 Picture 4. Current damper control

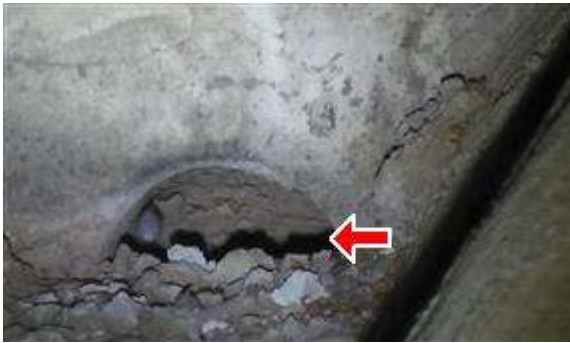
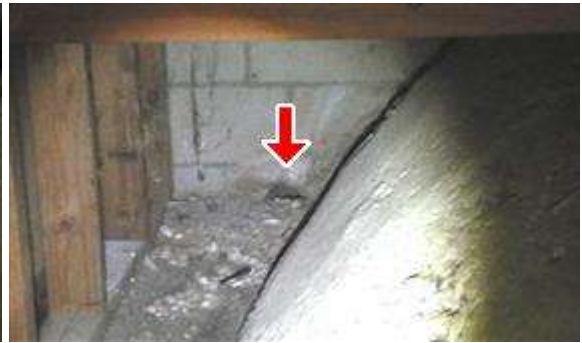
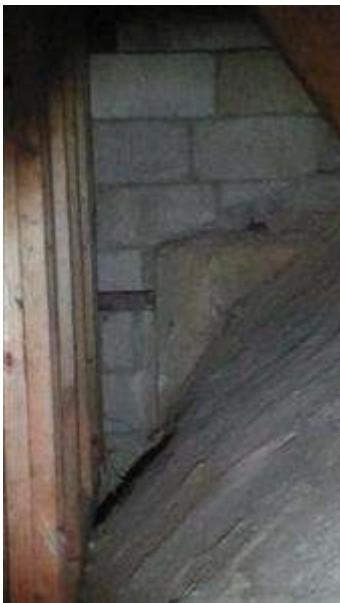
13.3 Picture 1

(1) Underneath this rear left corner in the crawl space at the bottom of the foundation wall there is a drain opening. I do not know where it terminates. It should be tested and evaluated. Currently there are some loose stones blocking the drain. Clear and evaluate. All drains of this kind should have a back flow preventer to avoid water intrusion into the interior.
