# Inspection Report

1060 Trail

Atlanta Georgia 30328

**Inspectors Associates, Inc.**

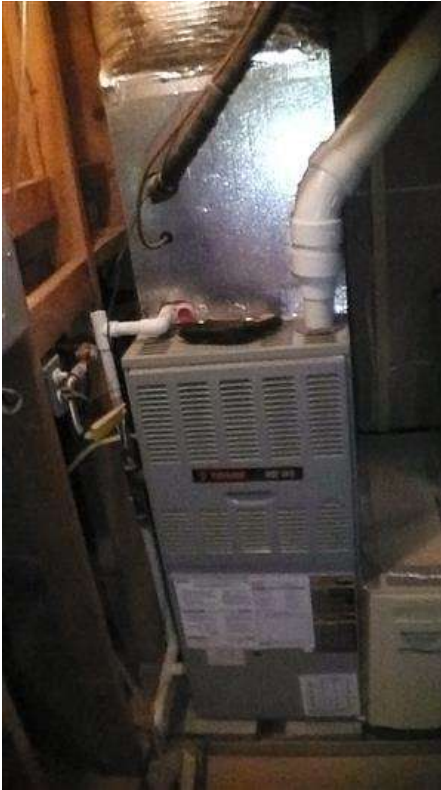
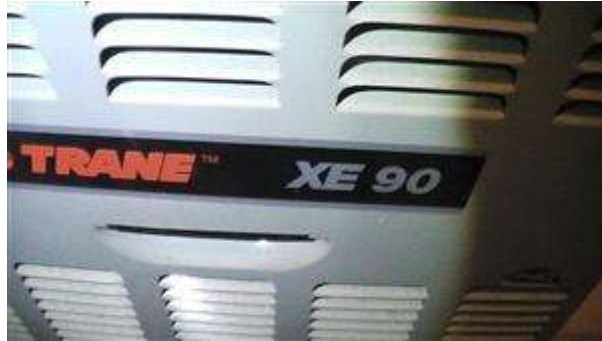
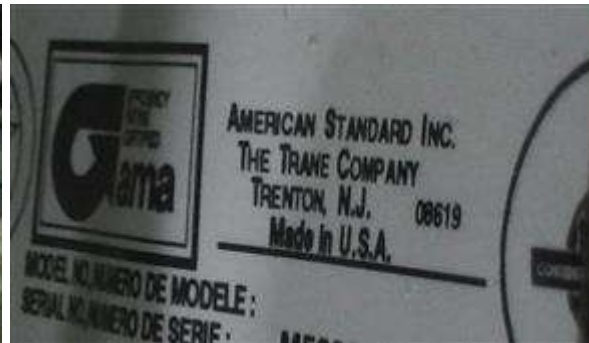
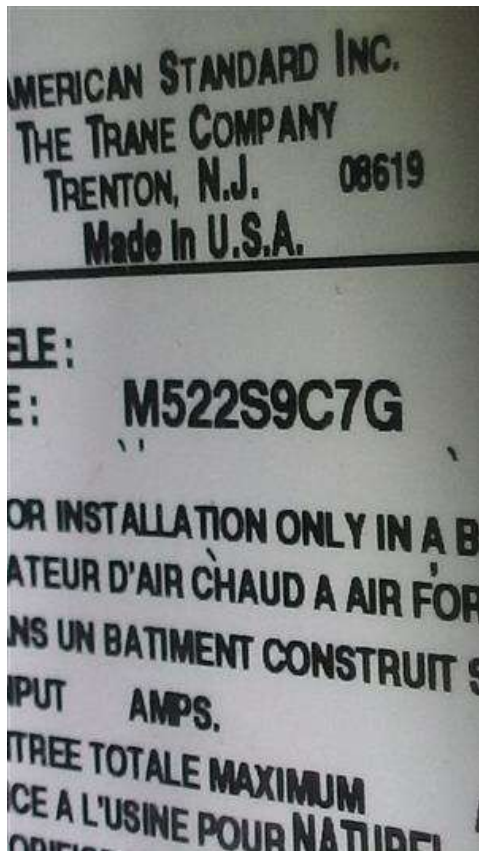
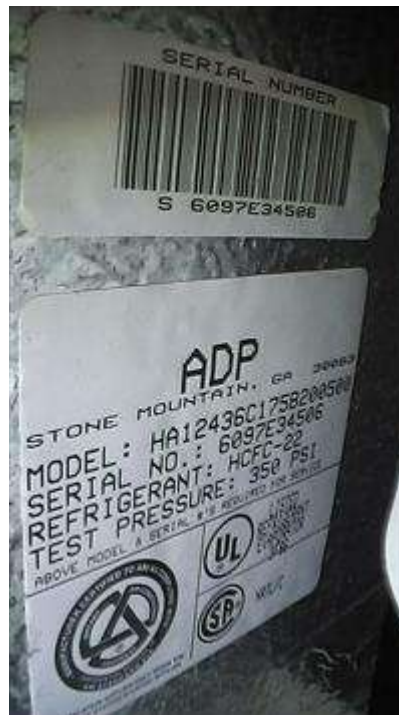
8.2 Picture 1

There is a secondary furnace system which manufactured by Train it has a safety shutoff valve and a condensate pump. The condensate pump needs to be put into a drain pan. This is a high-efficiency unit with a plastic vent pipe. Manufactured in 1997

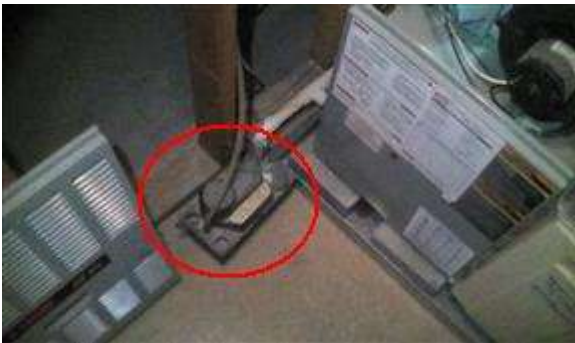
8.2 Picture 3. Place into a drip pan

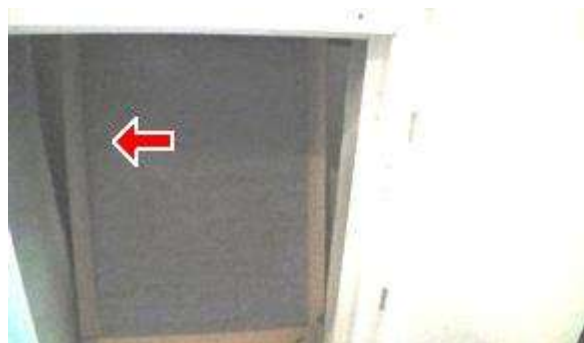
8.3 Picture 2. Not set into place correctly

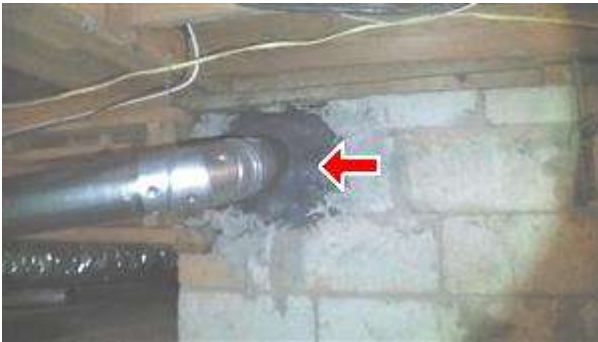
8.4 Picture 1

The flue vent exits the stack from the crawl space. This will need to be evaluated to make sure there is a protected exit of the gas fumes through the stack.

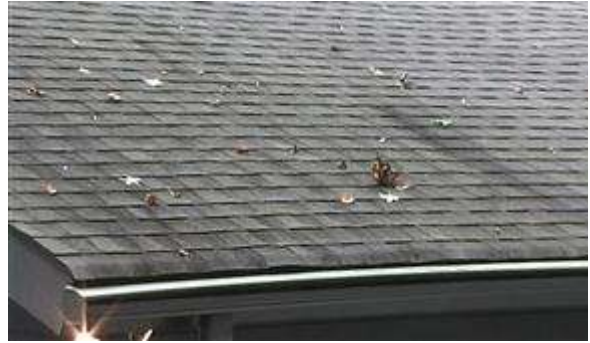
3.2 Picture 2

Roof is in need of cleaning and service. Repair damaged shingles,  
replace defective boots.

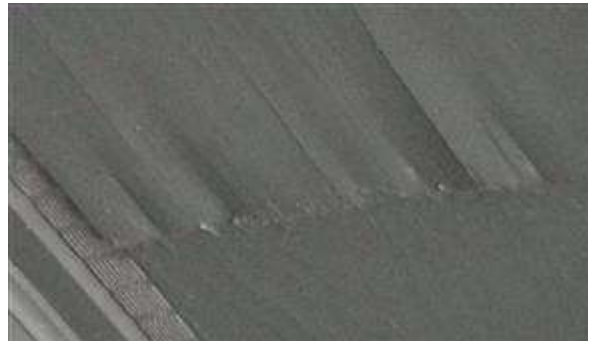
3.3 Picture 2

(1) On the rear left corner where the Valley is there soffit delamination that will need to be repaired. This is just as you walk out from the family room door.

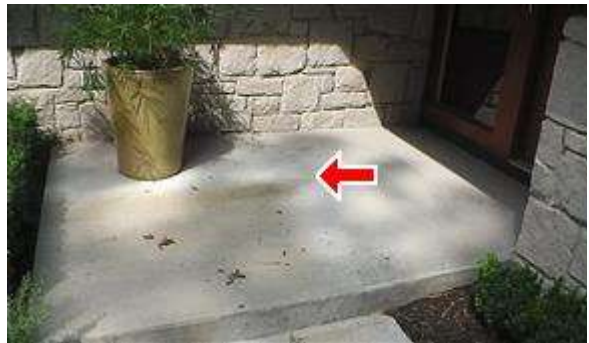
3.5 Picture 2. Water currently spills over the valley at the front entrance
